Access Compliance Report

Public Rights-of-Way

(Curb Ramps)

| Intersection ID: 1001741 | Main Street: FLAT_RIVER_DR | Cross Street: OVERLAND_PARK_LN | Location: W |

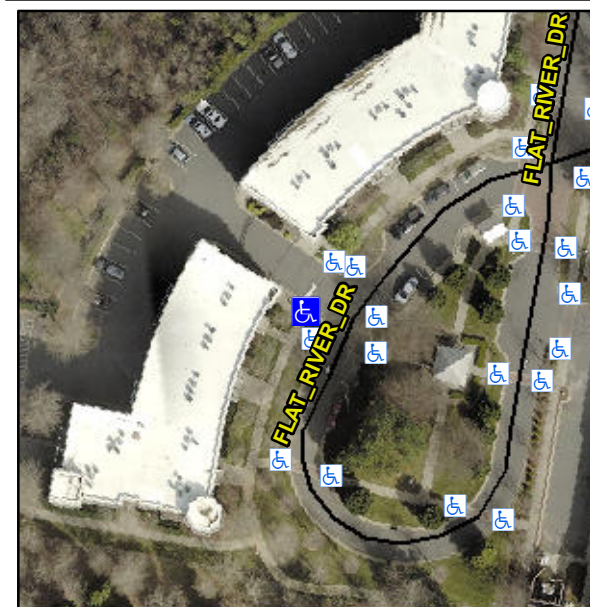
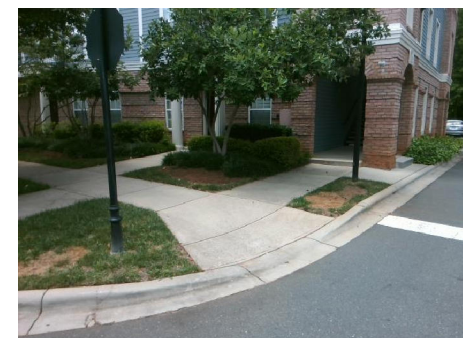
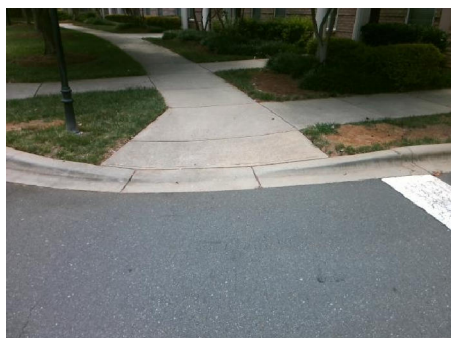
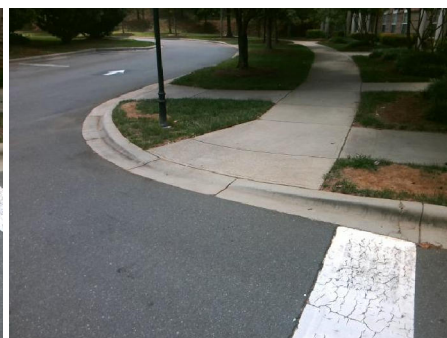
| ADA ID: 60128B0527F6 | Ramp Type: Perp | Initial Pass/Fail: Fail | Overall Compliance: No |
| Severity Score: 26.25 | | | |

| Compliance | Description | Data | Compliance | Description | Data |
|---|---|---|---|---|---|
| N/A | Ramp Length (in) | 35.5 | No | Ramp Slope (%) | 12.2 |
| Yes | Ramp Width (in) | 48.5 | No | Ramp XSlope (%) | 3.3 |

Remove & Replace Entire Ramp.

R304.2.2, R304.5.3
