Access Compliance Report Public Rights-of-Way (Curb Ramps)

Intersection ID: N/AMain Street: HAMILTON_BRIDGE_RDCross Street: OBAN_PASSAGE_DRLocation:NEADA ID: 604305ECAAD9Ramp Type: PerpInitial Pass/Fail: FailOverall Compliance: NoSeverity Score: 22.5

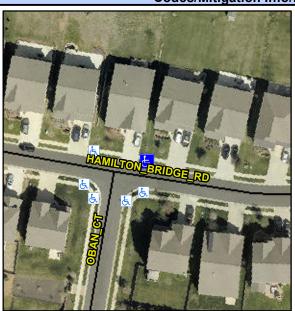
Field Measurements/Component Compliance						
Compl	iance Description	Data	Comp	liance Description	Data	
N/A	Ramp Length (in)	47.0	No	Ramp Slope (%)	10.6	
No	Ramp Width (in)	47.0	Yes	Ramp XSlope (%)	3.0	
N/A	Flare Type LT	N/A	N/A	Flare Type RT	N/A	
N/A	Flare Slope LT (%)	N/A	N/A	Flare Slope RT (%)	N/A	
N/A	Flare Traversable LT?	N/A	N/A	Flare Traversable RT?	N/A	
N/A	Landing Length (in)	N/A	N/A	DWS Provided?	N/A	
N/A	Landing Width (in)	N/A	N/A	DWS Contrast?	N/A	
N/A	Landing Slope (%)	N/A	N/A	DWS Length (in)	N/A	
N/A	Landing X Slope (%)	N/A	N/A	DWS Full Width?	N/A	
N/A	Landing Curb? (Y/N)	N/A	N/A	DWS Offset (in)	N/A	
N/A	Shared Landing?	N/A				
N/A	Gutter Ponding?	N/A	N/A	Gutter Slope (%)	N/A	
N/A	Gutter Lip Ht (in)	1.0	N/A	Gutter X Slope (%)	N/A	
N/A	Painted X Walk1?	No	N/A	Painted X Walk2?	N/A	
	X Walk 1 Direction	To SW		X Walk 2 Direction	N/A	
N/A	X Walk 1 Width (in)	N/A	N/A	X Walk 2 Width (in)	N/A	
	X Walk 1 Slope (%)	1.9		X Walk 2 Slope (%)	N/A

X Walk 1 X Slope (%)	5.2		X Walk 2 X Slope (%)	N/A	
N/A	Ramp inside XWalk1?	N/A	N/A	Ramp inside XWalk2?	N/A	
	Road Slope (%)	N/A	N/A	Clear Space?	N/A	
	Road X Slope (%)	N/A	N/A	Clear Space to XWalk (in)	N/A	
N/A	Any Obstructions?	N/A	N/A	Storm Grate/Utility Hazard?	N/A	
	Obstruction Type			Storm Grate/Utility Type		
		N/A			N/A	
			Yes	Surface Condition? (G/P)	Good

Possible Solutions:						
Remove & Replace Entire Ramp.						
	i					
Surveyor Notes:	ı					
N/A	I					
	ı					
PROW/ADA:						
Not Found, R304.5.1, R304.2.2	ı					
	ı					
	ı
