Access Compliance Report

Public Rights-of-Way

(Curb Ramps)

Intersection ID: 16598	Main Street: CRAIG_AV	Cross Street: RICHLAND_DR	Location:	N
ADA ID: 605C4672CF9B	Ramp Type: PerpDiag	Initial Pass/Fail: Fail	Overall Compliance: No	Severity Score: 25
Codes/Mitigation Info/Possible Solution		Field Measurements/Component Compliance

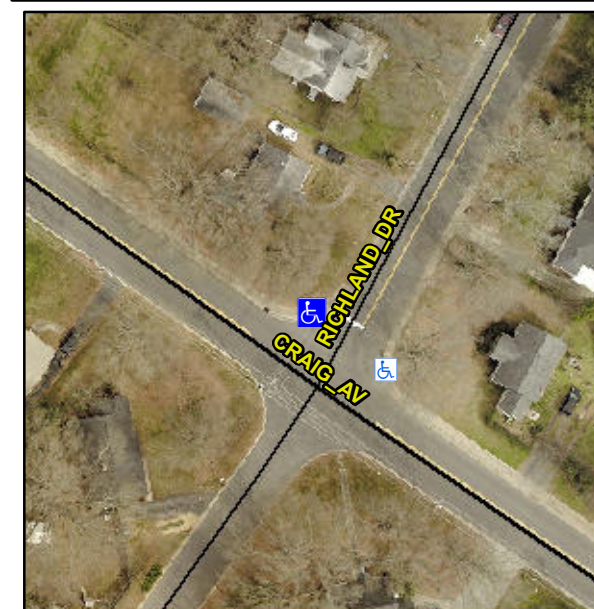
Not Found, R304.2.2

Compliance	Description	Data	Compliance	Description	Data
N/A	Ramp Length (in)	40.0	No	Ramp Slope (%)	14.4
Yes	Ramp Width (in)	48.0	Yes	Ramp XSlope (%)	1.1
N/A	Flare Type LT	N/A	N/A	Flare Type RT	N/A
N/A	Flare Slope LT (%)	N/A	N/A	Flare Slope RT (%)	N/A
N/A	Flare Traversable LT?	N/A	N/A	Flare Traversable RT?	N/A
N/A	Landing Length (in)	N/A	N/A	DWS Provided?	N/A
N/A	Landing Width (in)	N/A	N/A	DWS Contrast?	N/A
N/A	Landing Slope (%)	N/A	N/A	DWS Length (in)	N/A
N/A	Landing X Slope (%)	N/A	N/A	DWS Full Width?	N/A
N/A	Landing Curb? (Y/N)	N/A	N/A	DWS Offset (in)	N/A
N/A	Shared Landing?	N/A			
N/A	Gutter Ponding?	N/A	N/A	Gutter Slope (%)	N/A
N/A	Gutter Lip Ht (in)	N/A	N/A	Gutter X Slope (%)	N/A
N/A	Painted X Walk1?	No	N/A	Painted X Walk2?	No
	X Walk 1 Direction	To SW		X Walk 2 Direction	To SE
N/A	X Walk 1 Width (in)	N/A	N/A	X Walk 2 Width (in)	N/A
	X Walk 1 Slope (%)	2.6		X Walk 2 Slope (%)	2.3
	X Walk 1 X Slope (%)	0.5		X Walk 2 X Slope (%)	0.3

Remove & Replace Curb Ramp With Two New Directional Ramps or Equivalent.
