## **Access Compliance Report Public Rights-of-Way** (Curb Ramps)

Intersection ID: 12681 Main Street: PALOVERDE\_LN Cross Street: PENCE\_RD Location: NE **Overall Compliance: No** ADA ID: 605E7B1F0768 Ramp Type: Perp Initial Pass/Fail: Fail **Severity Score:** 8.75

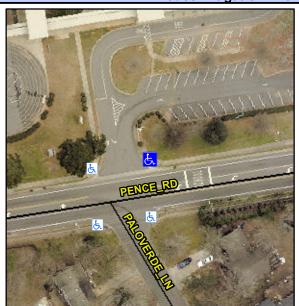
Field Measurements/Component Compliance						
Comp	liance Description	Data	Comp	liance Description	Data	
N/A	Ramp Length (in)	83.0	Yes	Ramp Slope (%)	6.2	
No	Ramp Width (in)	38.5	Yes	Ramp XSlope (%)	1.0	
N/A	Flare Type LT	N/A	N/A	Flare Type RT	N/A	
N/A	Flare Slope LT (%)	N/A	N/A	Flare Slope RT (%)	N/A	
N/A	Flare Traversable LT?	N/A	N/A	Flare Traversable RT?	N/A	
N/A	Landing Length (in)	N/A	N/A	DWS Provided?	N/A	
N/A	Landing Width (in)	N/A	N/A	DWS Contrast?	N/A	
N/A	Landing Slope (%)	N/A	N/A	DWS Length (in)	N/A	
N/A	Landing X Slope (%)	N/A	N/A	DWS Full Width?	N/A	
N/A	Landing Curb? (Y/N)	N/A	N/A	DWS Offset (in)	N/A	
N/A	Shared Landing?	N/A				
N/A	Gutter Ponding?	N/A	N/A	Gutter Slope (%)	N/A	
N/A	Gutter Lip Ht (in)	N/A	N/A	Gutter X Slope (%)	N/A	
N/A	Painted X Walk1?	No	N/A	Painted X Walk2?	N/A	
	X Walk 1 Direction	To S		X Walk 2 Direction	N/A	
N/A	X Walk 1 Width (in)	N/A	N/A	X Walk 2 Width (in)	N/A	
	X Walk 1 Slope (%)	4.8		X Walk 2 Slope (%)	N/A

rossible solution	
Possible Solutions:	Com
Remove & Replace Entire Ramp.	N/A
	No
	N/A
	N/A
	N/A
	N/A
Surveyor Notes:	N/A
N/A	N/A
	N/A
	N/A
	N/A
PROW/ADA:	N/A
Not Found, R304.5.1	N/A
	N/A
	N/A
	N/A
