Access Compliance Report

Public Rights-of-Way

(Curb Ramps)

Intersection ID: 28440	Main Street: DEARMON_RD	Cross Street: PROSPERITY_VILLAGE_DR	Location: NW
ADA ID: 606D85BFBB0B	Ramp Type: Perp	Initial Pass/Fail: Fail	Overall Compliance: No
Severity Score: 50			
Codes/Mitigation Info/Possible Solution		Field Measurements/Component Compliance

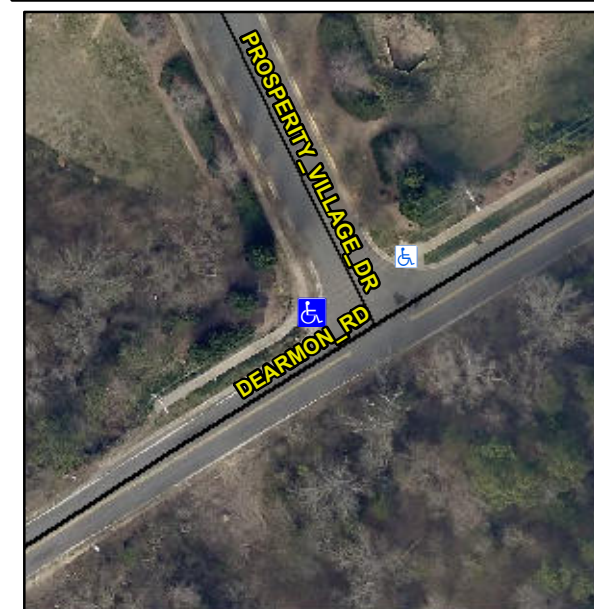
R304.2.2, R304.5.3

Compliance	Description	Data	Compliance	Description	Data
N/A	Ramp Length (in)	77.0	No	Ramp Slope (%)	20.0
Yes	Ramp Width (in)	50.0	No	Ramp XSlope (%)	11.1
N/A	Flare Type LT	N/A	N/A	Flare Type RT	N/A
N/A	Flare Slope LT (%)	N/A	N/A	Flare Slope RT (%)	N/A
N/A	Flare Traversable LT?	N/A	N/A	Flare Traversable RT?	N/A
N/A	Landing Length (in)	N/A	N/A	DWS Provided?	N/A
N/A	Landing Width (in)	N/A	N/A	DWS Contrast?	N/A
N/A	Landing Slope (%)	N/A	N/A	DWS Length (in)	N/A
N/A	Landing X Slope (%)	N/A	N/A	DWS Full Width?	N/A
N/A	Landing Curb? (Y/N)	N/A	N/A	DWS Offset (in)	N/A
N/A	Shared Landing?	N/A			
N/A	Gutter Ponding?	N/A	N/A	Gutter Slope (%)	N/A
N/A	Gutter Lip Ht (in)	N/A	N/A	Gutter X Slope (%)	N/A
N/A	Painted X Walk1?	No	N/A	Painted X Walk2?	N/A
	X Walk 1 Direction	To E		X Walk 2 Direction	N/A
N/A	X Walk 1 Width (in)	N/A	N/A	X Walk 2 Width (in)	N/A
	X Walk 1 Slope (%)	4.7		X Walk 2 Slope (%)	N/A
	X Walk 1 X Slope (%)	5.4		X Walk 2 X Slope (%)	N/A

Possible Solutions:

Remove & Replace Entire Ramp.
