Access Compliance Report Public Rights-of-Way (Curb Ramps)

Intersection ID: N/A Main Street: IDLEWILD RD Cross Street: MARGARET_WALLACE_RD Location: W ADA ID: 608F4862B4AE Ramp Type: PerpDiag Initial Pass/Fail: Fail **Overall Compliance: No Severity Score:** 8.75

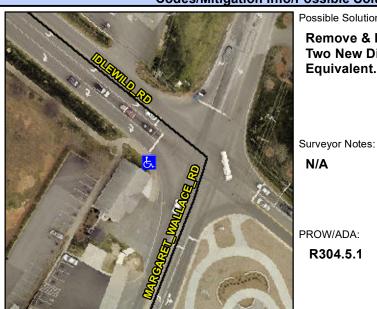
Field Measurements/Component Compliance						
Compliance Description		Data	Comp	liance Description	Data	
N/A	Ramp Length (in)	74.0	Yes	Ramp Slope (%)	5.3	
No	Ramp Width (in)	46.5	Yes	Ramp XSlope (%)	2.0	
N/A	Flare Type LT	N/A	N/A	Flare Type RT	N/A	
N/A	Flare Slope LT (%)	N/A	N/A	Flare Slope RT (%)	N/A	
N/A	Flare Traversable LT?	N/A	N/A	Flare Traversable RT?	N/A	
N/A	Landing Length (in)	N/A	N/A	DWS Provided?	N/A	
N/A	Landing Width (in)	N/A	N/A	DWS Contrast?	N/A	
N/A	Landing Slope (%)	N/A	N/A	DWS Length (in)	N/A	
N/A	Landing X Slope (%)	N/A	N/A	DWS Full Width?	N/A	
N/A	Landing Curb? (Y/N)	N/A	N/A	DWS Offset (in)	N/A	
N/A	Shared Landing?	N/A				
N/A	Gutter Ponding?	N/A	N/A	Gutter Slope (%)	N/A	
N/A	Gutter Lip Ht (in)	N/A	N/A	Gutter X Slope (%)	N/A	
N/A	Painted X Walk1?	No	N/A	Painted X Walk2?	No	
	X Walk 1 Direction	To SE		X Walk 2 Direction	To NE	
N/A	X Walk 1 Width (in)	N/A	N/A	X Walk 2 Width (in)	N/A	
	X Walk 1 Slope (%)	2.1		X Walk 2 Slope (%)	6.7

X Walk 1 X Slope (%)	6.4		X Walk 2 X Slope (%)	0.5	
N/A	Ramp inside XWalk1?	N/A	N/A	Ramp inside XWalk2?	N/A	
	Road Slope (%)	0.7	N/A	Clear Space?	N/A	
	Road X Slope (%)	7.6	N/A	Clear Space to XWalk (in)	N/A	
N/A	Any Obstructions?	N/A	N/A	Storm Grate/Utility Hazard?	N/A	
	Obstruction Type			Storm Grate/Utility Type		
		N/A			N/A	
			Yes	Surface Condition? (G/P)	Good

Possible Solutions: Remove & Replace Curb Ramp With **Two New Directional Ramps or** Equivalent.

Total Cost: 3200.00
