# Access Compliance Report

## Public Rights-of-Way

### (Curb Ramps)

Intersection ID: 48139	Main Street: BEATY_CALDWELL_LN	Cross Street: WEDDINGTON_RD	Location: SE
ADA ID: 6093BC9F7C33	Ramp Type: Perpendicular	Initial Pass/Fail: Fail	Overall Compliance: No
		Severity Score: 8.75

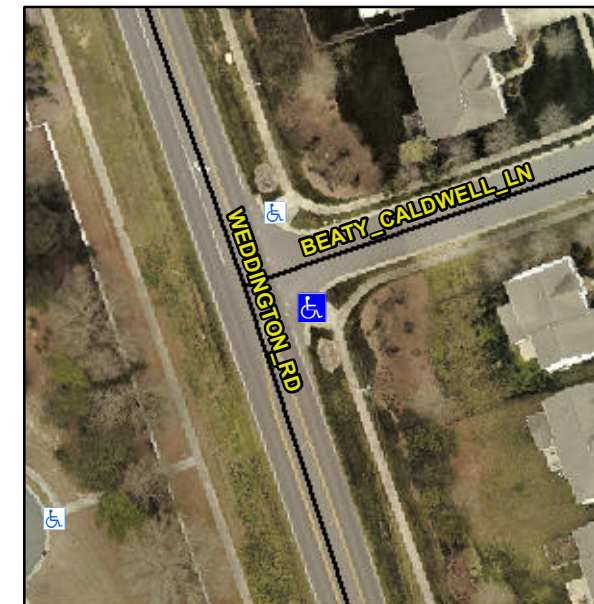
Compliance	Description	Data	Compliance	Description	Data
N/A	Ramp Length (in)	152.5	Yes	Ramp Slope (%)	5.0
No	Ramp Width (in)	47.0	Yes	Ramp XSlope (%)	0.3
N/A	Flare Type LT	N/A	N/A	Flare Type RT	N/A
N/A	Flare Slope LT (%)	N/A	N/A	Flare Slope RT (%)	N/A
N/A	Flare Traversable LT?	N/A	N/A	Flare Traversable RT?	N/A
N/A	Landing Length (in)	N/A	N/A	DWS Provided?	N/A
N/A	Landing Width (in)	N/A	N/A	DWS Contrast?	N/A
N/A	Landing Slope (%)	N/A	N/A	DWS Length (in)	N/A
N/A	Landing X Slope (%)	N/A	N/A	DWS Full Width?	N/A
N/A	Landing Curb? (Y/N)	N/A	N/A	DWS Offset (in)	N/A
N/A	Shared Landing?	N/A			
N/A	Gutter Ponding?	N/A	N/A	Gutter Slope (%)	N/A
N/A	Gutter Lip Ht (in)	N/A	N/A	Gutter X Slope (%)	N/A
N/A	Painted X Walk1?	No	N/A	Painted X Walk2?	N/A
	X Walk 1 Direction	To N		X Walk 2 Direction	N/A
N/A	X Walk 1 Width (in)	N/A	N/A	X Walk 2 Width (in)	N/A
	X Walk 1 Slope (%)	0.6		X Walk 2 Slope (%)	N/A
	X Walk 1 X Slope (%)	0.4		X Walk 2 X Slope (%)	N/A

N/A	Ramp inside XWalk1?	N/A	N/A	Ramp inside XWalk2?	N/A
	Road Slope (%)	N/A	N/A	Clear Space?	N/A
	Road X Slope (%)	N/A	N/A	Clear Space to XWalk (in)	N/A
N/A	Any Obstructions?	N/A	N/A	Storm Grate/Utility Hazard?	N/A
	Obstruction Type			Storm Grate/Utility Type	
		N/A			N/A
		Yes		Surface Condition? (G/P)	Good

Possible Solutions:

**Remove & Replace Entire Ramp.**

**R304.5.1**
