Access Compliance Report

Public Rights-of-Way

(Curb Ramps)

Intersection ID: 53160	Main Street: PERTH_MOOR_RD	Cross Street: HAMILTON_BRIDGE_RD	Location: NW
ADA ID: 6095F4F075BA	Ramp Type: Perp	Initial Pass/Fail: Fail	Overall Compliance: No
Severity Score: 22.5			
Codes/Mitigation Info/Possible Solution		Field Measurements/Component Compliance

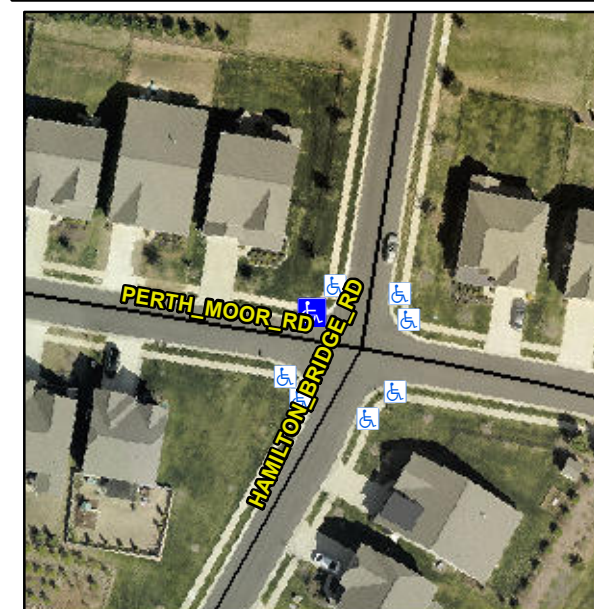
Not Found, R304.5.1, R304.2.2, R304.5.3

Compliance	Description	Data	Compliance	Description	Data
N/A	Ramp Length (in)	49.0	No	Ramp Slope (%)	10.8
No	Ramp Width (in)	46.5	No	Ramp XSlope (%)	4.2
N/A	Flare Type LT	N/A	N/A	Flare Type RT	N/A
N/A	Flare Slope LT (%)	N/A	N/A	Flare Slope RT (%)	N/A
N/A	Flare Traversable LT?	N/A	N/A	Flare Traversable RT?	N/A
N/A	Landing Length (in)	N/A	N/A	DWS Provided?	N/A
N/A	Landing Width (in)	N/A	N/A	DWS Contrast?	N/A
N/A	Landing Slope (%)	N/A	N/A	DWS Length (in)	N/A
N/A	Landing X Slope (%)	N/A	N/A	DWS Full Width?	N/A
N/A	Landing Curb? (Y/N)	N/A	N/A	DWS Offset (in)	N/A
N/A	Shared Landing?	N/A			
N/A	Gutter Ponding?	N/A	N/A	Gutter Slope (%)	N/A
N/A	Gutter Lip Ht (in)	1.5	N/A	Gutter X Slope (%)	N/A
N/A	Painted X Walk1?	No	N/A	Painted X Walk2?	N/A
	X Walk 1 Direction	To SW		X Walk 2 Direction	N/A
N/A	X Walk 1 Width (in)	N/A	N/A	X Walk 2 Width (in)	N/A
	X Walk 1 Slope (%)	2.7		X Walk 2 Slope (%)	N/A
	X Walk 1 X Slope (%)	2.4		X Walk 2 X Slope (%)	N/A

Possible Solutions:

Remove & Replace Entire Ramp.
