# Access Compliance Report

## Public Rights-of-Way

### (Curb Ramps)

Intersection ID: 24123	Main Street: SOUTH_BRIDGE_CR	Cross Street: SOUTH_POINT_BV	Location: SE
ADA ID: 60AD7AEE2E0C	Ramp Type: Perp	Initial Pass/Fail: Fail	Overall Compliance: No
			Severity Score: 18.75

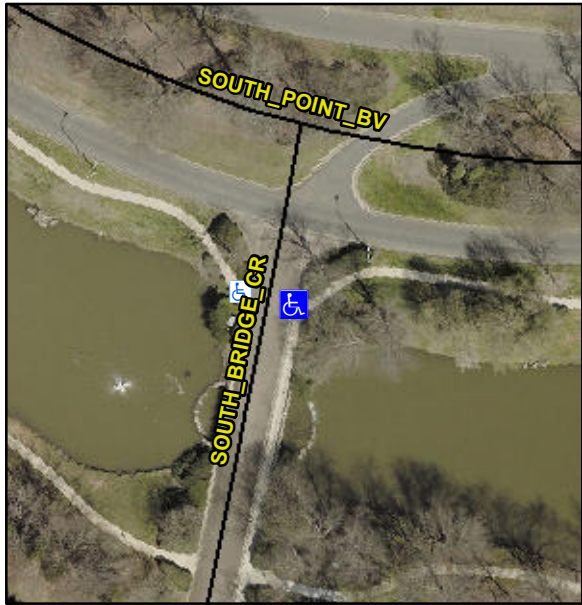
Possible Solutions:		Compliance	Description	Data	Compliance	Description	Data
	Remove & Replace Entire Ramp.		N/A	Ramp Length (in)	58.0	Yes	Ramp Slope (%)	6.7
			No	Ramp Width (in)	34.0	No	Ramp XSlope (%)	4.2
			N/A	Flare Type LT	N/A	N/A	Flare Type RT	N/A
			N/A	Flare Slope LT (%)	N/A	N/A	Flare Slope RT (%)	N/A
			N/A	Flare Traversable LT?	N/A	N/A	Flare Traversable RT?	N/A
			N/A	Landing Length (in)	N/A	N/A	DWS Provided?	N/A
			N/A	Landing Width (in)	N/A	N/A	DWS Contrast?	N/A
			N/A	Landing Slope (%)	N/A	N/A	DWS Length (in)	N/A
			N/A	Landing X Slope (%)	N/A	N/A	DWS Full Width?	N/A
Surveyor Notes:			N/A	Landing Curb? (Y/N)	N/A	N/A	DWS Offset (in)	N/A
N/A			N/A	Shared Landing?	N/A			
PROW/ADA:			N/A	Gutter Ponding?	N/A	N/A	Gutter Slope (%)	N/A
Not Found, R304.5.1, R304.5.3			N/A	Gutter Lip Ht (in)	N/A	N/A	Gutter X Slope (%)	N/A

N/A	Painted X Walk1?	No	N/A	Painted X Walk2?	N/A
				X Walk 1 Direction	To W		X Walk 2 Direction	N/A
			N/A	X Walk 1 Width (in)	N/A	N/A	X Walk 2 Width (in)	N/A
				X Walk 1 Slope (%)	3.8		X Walk 2 Slope (%)	N/A
				X Walk 1 X Slope (%)	2.8		X Walk 2 X Slope (%)	N/A
			N/A	Ramp inside XWalk1?	N/A	N/A	Ramp inside XWalk2?	N/A
				Road Slope (%)	N/A	N/A	Clear Space?	N/A
				Road X Slope (%)	N/A	N/A	Clear Space to XWalk (in)	N/A
			N/A	Any Obstructions?	N/A	N/A	Storm Grate/Utility Hazard?	N/A
				Obstruction Type			Storm Grate/Utility Type	
					N/A			N/A
						Yes	Surface Condition? (G/P)	Good
