# Access Compliance Report

## Public Rights-of-Way

### (Curb Ramps)

Intersection ID: 9356	Main Street: E_36TH_ST	Cross Street: N_TRYON_ST	Location: NW
ADA ID: 60B9ED23D950	Ramp Type: Perp	Initial Pass/Fail: Fail	Overall Compliance: No
			Severity Score: 46.25

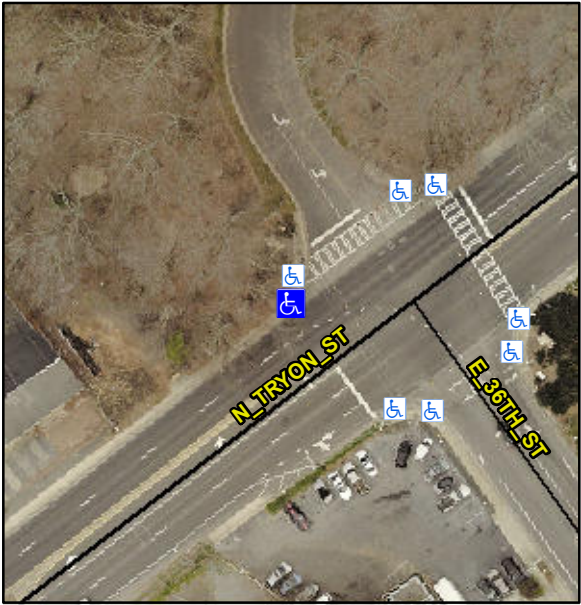
Possible Solutions:		<b>Compliance</b>	<b>Description</b>	<b>Data</b>	<b>Compliance</b>
	<b>Remove &amp; Replace Entire Ramp.</b>		<b>No</b>	Ramp Length (in)	<b>60.0</b>	<b>No</b>
			<b>No</b>	Ramp Width (in)	<b>36.0</b>	<b>No</b>
			<b>N/A</b>	Flare Type LT	<b>N/A</b>	<b>N/A</b>
			<b>N/A</b>	Flare Slope LT (%)	<b>N/A</b>	<b>N/A</b>
			<b>N/A</b>	Flare Traversable LT?	<b>N/A</b>	<b>N/A</b>
			<b>N/A</b>	Landing Length (in)	<b>N/A</b>	<b>N/A</b>
			<b>N/A</b>	Landing Width (in)	<b>N/A</b>	<b>N/A</b>
			<b>N/A</b>	Landing Slope (%)	<b>N/A</b>	<b>N/A</b>
			<b>N/A</b>	Landing X Slope (%)	<b>N/A</b>	<b>N/A</b>
<p>Surveyor Notes:</p> <p><b>N/A</b></p> <p>PROW/ADA:</p> <p><b>Not Found, R304.5.1, R304.2.2, R304.5.3</b></p>			<b>N/A</b>	Flare Type RT	<b>N/A</b>	<b>N/A</b>
			<b>N/A</b>	Flare Slope RT (%)	<b>N/A</b>	<b>N/A</b>

<b>N/A</b>	Flare Traversable RT?	<b>N/A</b>	<b>N/A</b>
			<b>N/A</b>	DWS Provided?	<b>N/A</b>	<b>N/A</b>
			<b>N/A</b>	DWS Contrast?	<b>N/A</b>	<b>N/A</b>
			<b>N/A</b>	DWS Length (in)	<b>N/A</b>	<b>N/A</b>
			<b>N/A</b>	DWS Full Width?	<b>N/A</b>	<b>N/A</b>
			<b>N/A</b>	DWS Offset (in)	<b>N/A</b>	<b>N/A</b>
			<b>N/A</b>	Gutter Slope (%)	<b>N/A</b>	<b>N/A</b>
			<b>N/A</b>	Gutter X Slope (%)	<b>N/A</b>	<b>N/A</b>
			<b>No</b>	Painted X Walk1?	<b>No</b>	<b>N/A</b>
				X Walk 1 Direction	<b>To SE</b>	<b>N/A</b>
			<b>N/A</b>	X Walk 1 Width (in)	<b>N/A</b>	<b>N/A</b>
				X Walk 1 Slope (%)	<b>2.8</b>	<b>N/A</b>
				X Walk 1 X Slope (%)	<b>5.6</b>	<b>N/A</b>
			<b>N/A</b>	Ramp inside XWalk1?	<b>N/A</b>	<b>N/A</b>
			<b>N/A</b>	Road Slope (%)	<b>N/A</b>	<b>N/A</b>
			<b>N/A</b>	Road X Slope (%)	<b>N/A</b>	<b>N/A</b>
			<b>N/A</b>	Any Obstructions?	<b>N/A</b>	<b>N/A</b>
				Obstruction Type		<b>N/A</b>
Total Cost:			<b>\$</b>	<b>1850.00</b>		<b>N/A</b>

<b>Yes</b>
						<b>Surface Condition? (G/P)</b>
						<b>Good</b>
