Access Compliance Report

Public Rights-of-Way

(Curb Ramps)

Intersection ID: N/A	Main Street: HAMILTON_BRIDGE_RD	Cross Street: OBAN_PASSAGE_DR	Location: SE
ADA ID: 60BAFCD60FBE	Ramp Type: Perp	Initial Pass/Fail: Fail	Overall Compliance: No
Severity Score: 46.25			
Codes/Mitigation Info/Possible Solution		Field Measurements/Component Compliance

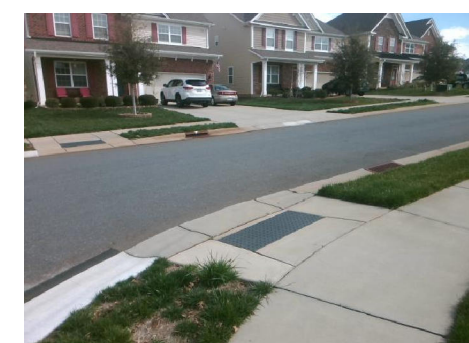
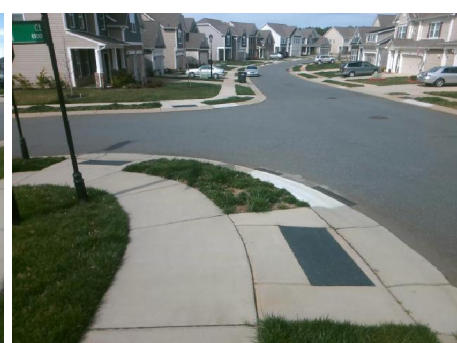
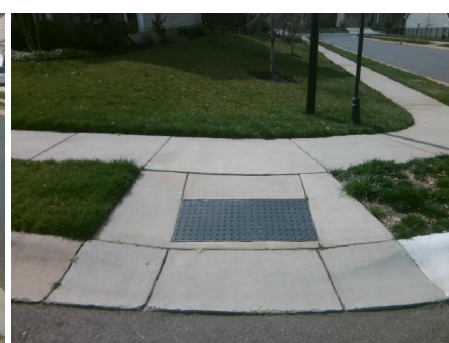
R304.5.1, R304.2.2, R304.5.3

Compliance	Description	Data	Compliance	Description	Data
N/A	Ramp Length (in)	48.0	No	Ramp Slope (%)	12.9
No	Ramp Width (in)	45.0	No	Ramp XSlope (%)	5.9
N/A	Flare Type LT	N/A	N/A	Flare Type RT	N/A
N/A	Flare Slope LT (%)	N/A	N/A	Flare Slope RT (%)	N/A
N/A	Flare Traversable LT?	N/A	N/A	Flare Traversable RT?	N/A
N/A	Landing Length (in)	N/A	N/A	DWS Provided?	N/A
N/A	Landing Width (in)	N/A	N/A	DWS Contrast?	N/A
N/A	Landing Slope (%)	N/A	N/A	DWS Length (in)	N/A
N/A	Landing X Slope (%)	N/A	N/A	DWS Full Width?	N/A
N/A	Landing Curb? (Y/N)	N/A	N/A	DWS Offset (in)	N/A
N/A	Shared Landing?	N/A			
N/A	Gutter Ponding?	N/A	N/A	Gutter Slope (%)	N/A
N/A	Gutter Lip Ht (in)	1.0	N/A	Gutter X Slope (%)	N/A
N/A	Painted X Walk1?	No	N/A	Painted X Walk2?	N/A
	X Walk 1 Direction	To NE		X Walk 2 Direction	N/A
N/A	X Walk 1 Width (in)	N/A	N/A	X Walk 2 Width (in)	N/A
	X Walk 1 Slope (%)	2.6		X Walk 2 Slope (%)	N/A
	X Walk 1 X Slope (%)	5.2		X Walk 2 X Slope (%)	N/A

N/A	Ramp inside XWalk1?	N/A	N/A	Ramp inside XWalk2?	N/A
	Road Slope (%)	N/A	N/A	Clear Space?	N/A
	Road X Slope (%)	N/A	N/A	Clear Space to XWalk (in)	N/A
N/A	Any Obstructions?	N/A	N/A	Storm Grate/Utility Hazard?	N/A
	Obstruction Type			Storm Grate/Utility Type	
		N/A			N/A
			Yes	Surface Condition? (G/P)	Good

Remove & Replace Entire Ramp.
