Access Compliance Report

Public Rights-of-Way

(Curb Ramps)

Intersection ID: 45794	Main Street: SHELLVIEW_LN	Cross Street: GRANITE_TRAIL_LN	Location: NE
ADA ID: 60BFC8542A0C	Ramp Type: BlendTrans1	Initial Pass/Fail: Fail	Overall Compliance: No
Severity Score: 12.5			
Codes/Mitigation Info/Possible Solution		Field Measurements/Component Compliance

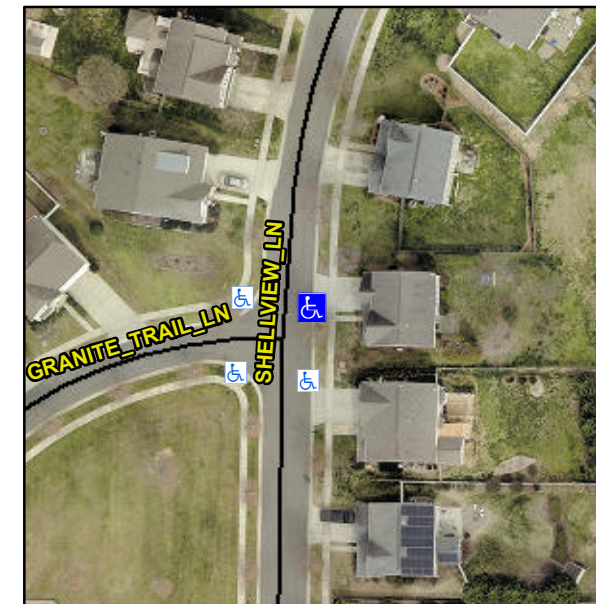
Not Found, R304.5.3

Compliance	Description	Data	Compliance	Description	Data
N/A	Ramp Length (in)	73.0	Yes	BlendTrans Slope (%)	2.1
Yes	Ramp Width (in)	48.0	No	BlendTrans XSlope (%)	5.1
N/A	Flare Type LT	N/A	N/A	Flare Type RT	N/A
N/A	Flare Slope LT (%)	N/A	N/A	Flare Slope RT (%)	N/A
N/A	Flare Traversable LT?	N/A	N/A	Flare Traversable RT?	N/A
N/A	Landing Length (in)	N/A	N/A	DWS Provided?	N/A
N/A	Landing Width (in)	N/A	N/A	DWS Contrast?	N/A
N/A	Landing Slope (%)	N/A	N/A	DWS Length (in)	N/A
N/A	Landing X Slope (%)	N/A	N/A	DWS Full Width?	N/A
N/A	Landing Curb? (Y/N)	N/A	N/A	DWS Offset (in)	N/A
N/A	Shared Landing?	N/A			
N/A	Gutter Ponding?	N/A	N/A	Gutter Slope (%)	N/A
N/A	Gutter Lip Ht (in)	N/A	N/A	Gutter X Slope (%)	N/A
N/A	Painted X Walk1?	No	N/A	Painted X Walk2?	N/A
	X Walk 1 Direction	To W		X Walk 2 Direction	N/A
	X Walk 1 Width (in)	N/A		X Walk 2 Width (in)	N/A
	X Walk 1 Slope (%)	3.1		X Walk 2 Slope (%)	N/A
	X Walk 1 X Slope (%)	3.0		X Walk 2 X Slope (%)	N/A

N/A	Ramp inside XWalk1?	N/A	N/A	Ramp inside XWalk2?	N/A
	Road Slope (%)	3.0		Clear Space?	N/A
	Road X Slope (%)	3.1	N/A	Clear Space to XWalk (in)	N/A
N/A	Any Obstructions?	N/A	N/A	Storm Grate/Utility Hazard?	N/A
	Obstruction Type			Storm Grate/Utility Type	
		N/A			N/A
			Yes	Surface Condition? (G/P)	Good
			No	Curb Slope (%)	21.4

Possible Solutions:

Remove & Replace Curb Ramp With Two New Directional Ramps or Equivalent.
