# Access Compliance Report

## Public Rights-of-Way

### (Curb Ramps)

| Intersection ID: 20185 | Main Street: FAIRVIEW_RD | Cross Street: PIEDMONT_ROW_DR | Location: NW |

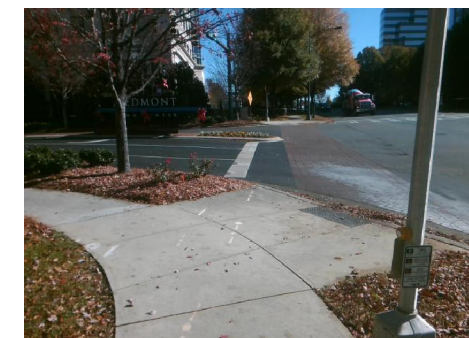
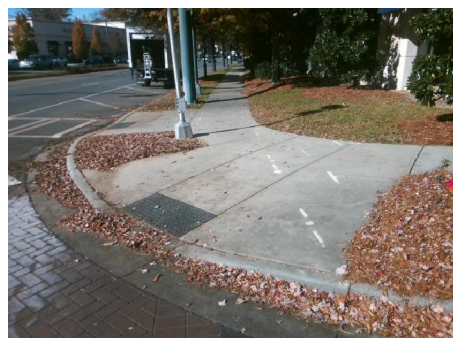
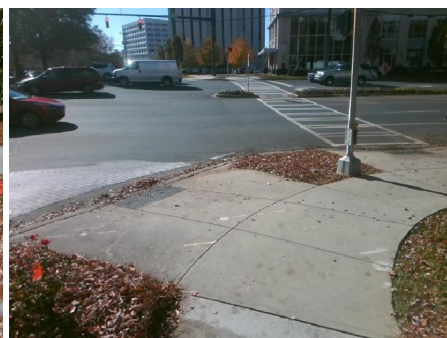
| ADA ID: 60C519456D80 | Ramp Type: Perp | Initial Pass/Fail: Fail | Overall Compliance: No |
| Severity Score: 13.75 | | | |

| Compliance | Description | Data | Compliance | Description | Data |
|---|---|---|---|---|---|
| N/A | Ramp Length (in) | 94.0 | No | Ramp Slope (%) | 8.7 |
| Yes | Ramp Width (in) | 48.0 | No | Ramp XSlope (%) | 3.2 |

**Remove & Replace Entire Ramp.**

**R304.2.2, R304.5.3**
