Access Compliance Report

Public Rights-of-Way

(Curb Ramps)

Intersection ID: 16122	Main Street: BEVERLY_DR	Cross Street: OXFORD_PL	Location: SE
ADA ID: 60D088700DF9	Ramp Type: PerpDiag	Initial Pass/Fail: Fail	Overall Compliance: No
Severity Score: 12.5			
Codes/Mitigation Info/Possible Solution		Field Measurements/Component Compliance

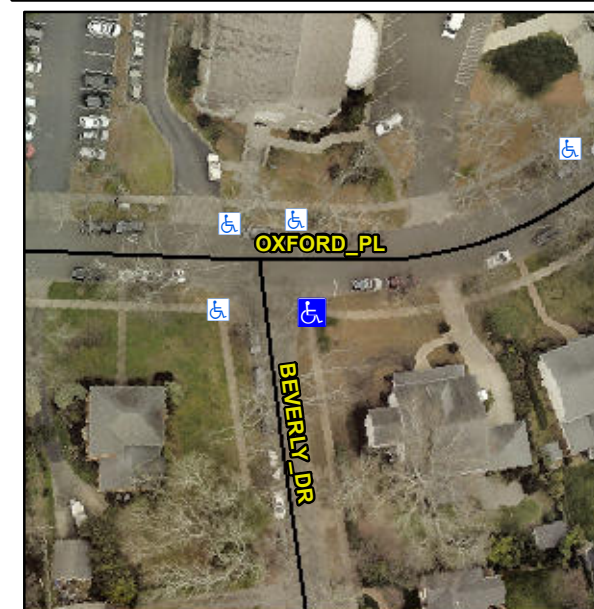
Not Found, R304.2.2

Compliance	Description	Data	Compliance	Description	Data
N/A	Ramp Length (in)	74.0	No	Ramp Slope (%)	9.9
Yes	Ramp Width (in)	48.0	Yes	Ramp XSlope (%)	1.0
N/A	Flare Type LT	N/A	N/A	Flare Type RT	N/A
N/A	Flare Slope LT (%)	N/A	N/A	Flare Slope RT (%)	N/A
N/A	Flare Traversable LT?	N/A	N/A	Flare Traversable RT?	N/A
N/A	Landing Length (in)	N/A	N/A	DWS Provided?	N/A
N/A	Landing Width (in)	N/A	N/A	DWS Contrast?	N/A
N/A	Landing Slope (%)	N/A	N/A	DWS Length (in)	N/A
N/A	Landing X Slope (%)	N/A	N/A	DWS Full Width?	N/A
N/A	Landing Curb? (Y/N)	N/A	N/A	DWS Offset (in)	N/A
N/A	Shared Landing?	N/A			
N/A	Gutter Ponding?	N/A	N/A	Gutter Slope (%)	N/A
N/A	Gutter Lip Ht (in)	N/A	N/A	Gutter X Slope (%)	N/A
N/A	Painted X Walk1?	No	N/A	Painted X Walk2?	No
	X Walk 1 Direction	To N		X Walk 2 Direction	To NW
N/A	X Walk 1 Width (in)	N/A	N/A	X Walk 2 Width (in)	N/A
	X Walk 1 Slope (%)	1.0		X Walk 2 Slope (%)	1.5
	X Walk 1 X Slope (%)	2.0		X Walk 2 X Slope (%)	3.0

N/A	Ramp inside XWalk1?	N/A	N/A	Ramp inside XWalk2?	N/A
	Road Slope (%)	1.4	N/A	Clear Space?	N/A
	Road X Slope (%)	3.3	N/A	Clear Space to XWalk (in)	N/A
N/A	Any Obstructions?	N/A	N/A	Storm Grate/Utility Hazard?	N/A
	Obstruction Type			Storm Grate/Utility Type	
		N/A			N/A
		Yes		Surface Condition? (G/P)	Good

Remove & Replace Curb Ramp With Two New Directional Ramps or Equivalent.

Total Cost: \$ 3200.00
