Access Compliance Report

Public Rights-of-Way

(Curb Ramps)

Intersection ID: 45629	Main Street: SARDIS_RD_NORTH	Cross Street: GALLERIA_BV	Location: NW
ADA ID: 60D1FB362253	Ramp Type: Perp	Initial Pass/Fail: Fail	Overall Compliance: No
Severity Score: 10			
Codes/Mitigation Info/Possible Solution		Field Measurements/Component Compliance

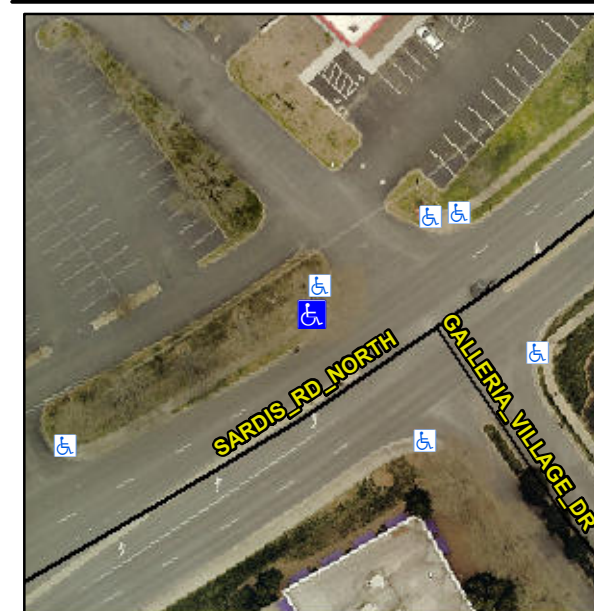
Not Found, R304.5.1, R304.5.3

Compliance	Description	Data	Compliance	Description	Data
N/A	Ramp Length (in)	72.0	Yes	Ramp Slope (%)	6.2
No	Ramp Width (in)	41.0	No	Ramp XSlope (%)	4.2
N/A	Flare Type LT	N/A	N/A	Flare Type RT	N/A
N/A	Flare Slope LT (%)	N/A	N/A	Flare Slope RT (%)	N/A
N/A	Flare Traversable LT?	N/A	N/A	Flare Traversable RT?	N/A
N/A	Landing Length (in)	N/A	N/A	DWS Provided?	N/A
N/A	Landing Width (in)	N/A	N/A	DWS Contrast?	N/A
N/A	Landing Slope (%)	N/A	N/A	DWS Length (in)	N/A
N/A	Landing X Slope (%)	N/A	N/A	DWS Full Width?	N/A
N/A	Landing Curb? (Y/N)	N/A	N/A	DWS Offset (in)	N/A
N/A	Shared Landing?	N/A			
N/A	Gutter Ponding?	N/A	N/A	Gutter Slope (%)	N/A
N/A	Gutter Lip Ht (in)	N/A	N/A	Gutter X Slope (%)	N/A
N/A	Painted X Walk1?	No	N/A	Painted X Walk2?	N/A
	X Walk 1 Direction	To SE		X Walk 2 Direction	N/A
N/A	X Walk 1 Width (in)	N/A	N/A	X Walk 2 Width (in)	N/A
	X Walk 1 Slope (%)	4.8		X Walk 2 Slope (%)	N/A
	X Walk 1 X Slope (%)	0.6		X Walk 2 X Slope (%)	N/A

N/A	Ramp inside XWalk1?	N/A	N/A	Ramp inside XWalk2?	N/A
	Road Slope (%)	N/A	N/A	Clear Space?	N/A
	Road X Slope (%)	N/A	N/A	Clear Space to XWalk (in)	N/A
N/A	Any Obstructions?	N/A	N/A	Storm Grate/Utility Hazard?	N/A
	Obstruction Type			Storm Grate/Utility Type	
		N/A			N/A
			Yes	Surface Condition? (G/P)	Good

Possible Solutions:

Remove & Replace Entire Ramp.
