# Access Compliance Report

## Public Rights-of-Way

Intersection ID: 24497	Main Street: BARDSTOWN_RD	Cross Street: MARYHURST_LN	Location:	N
ADA ID: 60E2D03115DA	Ramp Type: Perp	Initial Pass/Fail: Fail	Overall Compliance: No	Severity Score: 12.5

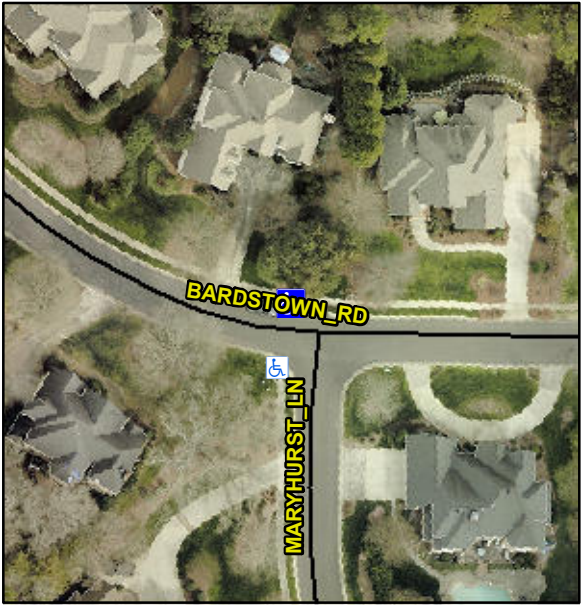
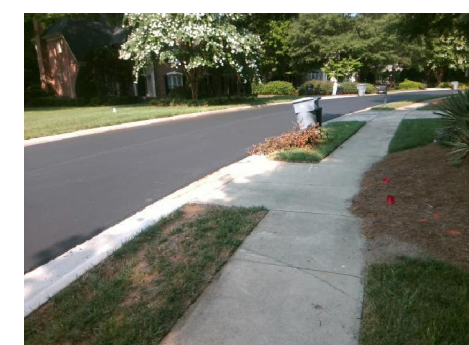
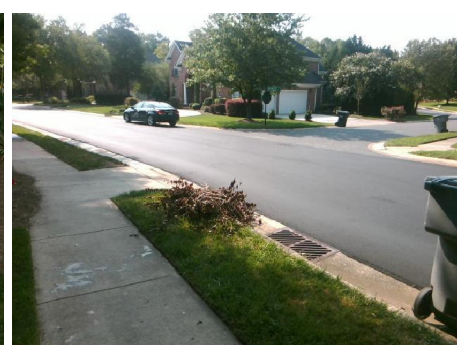
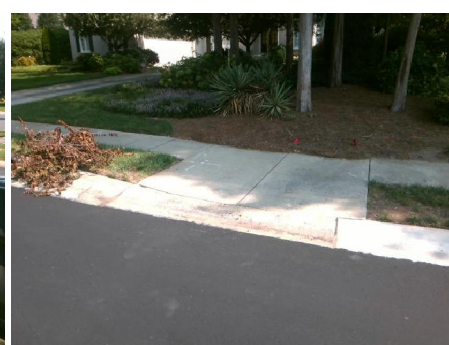
Possible Solutions:		<b>Compliance</b>	<b>Description</b>	<b>Data</b>
	<b>Remove &amp; Replace Entire Ramp.</b>		<b>Yes</b>	Ramp Length (in)	90.0
			<b>N/A</b>	Ramp Width (in)	113.0
			<b>N/A</b>	Flare Type LT	N/A
			<b>N/A</b>	Flare Slope LT (%)	N/A
			<b>N/A</b>	Flare Traversable LT?	N/A
			<b>N/A</b>	Flare Traversable RT?	N/A
			<b>N/A</b>	DWS Provided?	N/A
			<b>N/A</b>	DWS Contrast?	N/A
			<b>N/A</b>	DWS Length (in)	N/A
<p>Surveyor Notes:</p> <p><b>N/A</b></p>			<b>N/A</b>	DWS Full Width?	N/A
			<b>N/A</b>	DWS Offset (in)	N/A
			<b>N/A</b>	Shared Landing?	N/A
			<b>N/A</b>	Gutter Ponding?	N/A
			<b>N/A</b>	Gutter Lip Ht (in)	N/A
			<b>No</b>	Painted X Walk1?	N/A
			<b>To S</b>	X Walk 2 Direction	N/A
			<b>N/A</b>	X Walk 2 Width (in)	N/A
			<b>1.8</b>	X Walk 2 Slope (%)	N/A
			<b>0.4</b>	X Walk 2 X Slope (%)	N/A
<p>PROW/ADA:</p> <p><b>R304.5.3</b></p>			<b>N/A</b>	Ramp inside XWalk1?	N/A

<b>N/A</b>	Ramp inside XWalk2?	N/A
			<b>N/A</b>	Clear Space?	N/A
			<b>N/A</b>	Clear Space to XWalk (in)	N/A
			<b>N/A</b>	Storm Grate/Utility Hazard?	N/A
			<b>N/A</b>	Storm Grate/Utility Type	N/A
			<b>N/A</b>	Surface Condition? (G/P)	Good
<p>Total Cost:</p> <p><b>\$ 1850.00</b></p>
