Intersection ID: 8908	Main Street: RUSSELL_AV	Cross Street: WELCH_PL	Location:	SE
ADA ID: 60E882EE65E7	Ramp Type: Perp	Initial Pass/Fail: Fail	Overall Compliance: No	Severity Score: 1.25

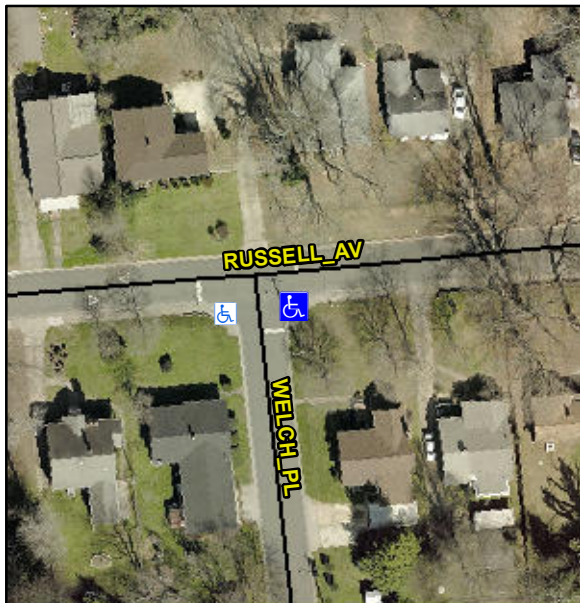
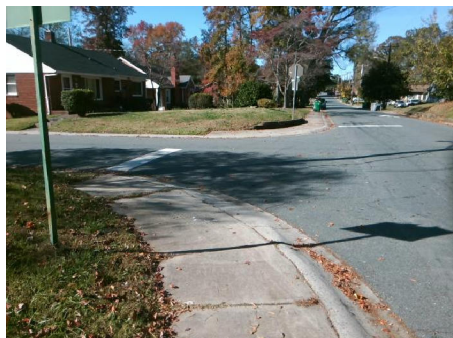
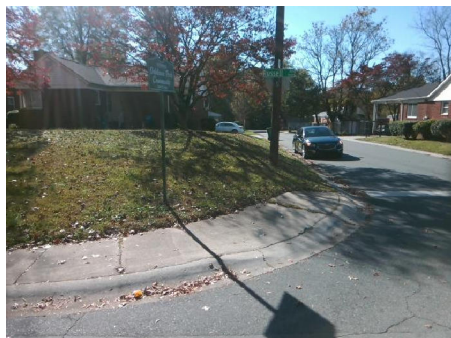
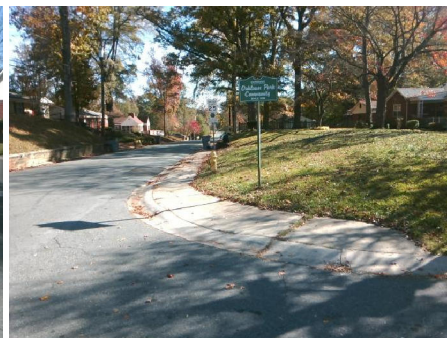
Possible Solutions:					Compliance			Description			Data				
	Remove & Replace Entire Ramp.					N/A			Ramp Length (in)			60.0				
						Yes			Ramp Width (in)			60.0				
						N/A			Flare Type LT			N/A				
						N/A			Flare Slope LT (%)			N/A				
						N/A			Flare Traversable LT?			N/A				
						N/A			Landing Length (in)			N/A				
						N/A			Landing Width (in)			N/A				
						N/A			Landing Slope (%)			N/A				
						N/A			Landing X Slope (%)			N/A				
Surveyor Notes:					N/A			N/A			DWS Provided?			N/A		
								N/A			DWS Contrast?			N/A		
								N/A			DWS Length (in)			N/A		
								N/A			DWS Full Width?			N/A		
								N/A			DWS Offset (in)			N/A		
								N/A								
PROW/ADA:					Not Found, R304.5.3			N/A			Gutter Ponding?			N/A		
								N/A			Gutter Lip Ht (in)			N/A		
								N/A			Painted X Walk1?			No

X Walk 1 Direction			To W		
								N/A			X Walk 1 Width (in)			N/A		
											X Walk 1 Slope (%)			2.4		
											X Walk 1 X Slope (%)			1.2		
								N/A			Ramp inside XWalk1?			N/A		
											Road Slope (%)			N/A		
											Road X Slope (%)			N/A		
								N/A			Any Obstructions?			N/A		
											Obstruction Type					
														N/A		
														Yes		
														Surface Condition? (G/P)		
														Good
