Access Compliance Report

Public Rights-of-Way

(Curb Ramps)

Intersection ID: 10020394	Main Street: BALLANTYNE CROSSING AV	Cross Street: N/A	Location: NE
ADA ID: 60E9E6FBEBBE	Ramp Type: PerpDiag	Initial Pass/Fail: Fail	Overall Compliance: No
Severity Score: 26.25			
Codes/Mitigation Info/Possible Solution		Field Measurements/Component Compliance

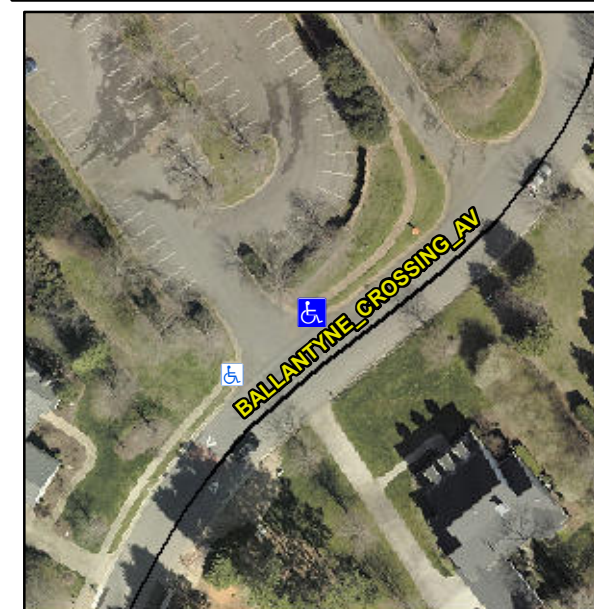
Not Found, R304.2.2, R304.5.3

Compliance	Description	Data	Compliance	Description	Data
N/A	Ramp Length (in)	48.0	No	Ramp Slope (%)	13.0
Yes	Ramp Width (in)	48.0	No	Ramp XSlope (%)	4.9
N/A	Flare Type LT	N/A	N/A	Flare Type RT	N/A
N/A	Flare Slope LT (%)	N/A	N/A	Flare Slope RT (%)	N/A
N/A	Flare Traversable LT?	N/A	N/A	Flare Traversable RT?	N/A
N/A	Landing Length (in)	N/A	N/A	DWS Provided?	N/A
N/A	Landing Width (in)	N/A	N/A	DWS Contrast?	N/A
N/A	Landing Slope (%)	N/A	N/A	DWS Length (in)	N/A
N/A	Landing X Slope (%)	N/A	N/A	DWS Full Width?	N/A
N/A	Landing Curb? (Y/N)	N/A	N/A	DWS Offset (in)	N/A
N/A	Shared Landing?	N/A			
N/A	Gutter Ponding?	N/A	N/A	Gutter Slope (%)	N/A
N/A	Gutter Lip Ht (in)	N/A	N/A	Gutter X Slope (%)	N/A
N/A	Painted X Walk1?	No	N/A	Painted X Walk2?	No
	X Walk 1 Direction	To SW		X Walk 2 Direction	To SE
N/A	X Walk 1 Width (in)	N/A	N/A	X Walk 2 Width (in)	N/A
	X Walk 1 Slope (%)	4.4		X Walk 2 Slope (%)	7.6
	X Walk 1 X Slope (%)	0.0		X Walk 2 X Slope (%)	8.2

N/A	Ramp inside XWalk1?	N/A	N/A	Ramp inside XWalk2?	N/A
	Road Slope (%)	6.8	N/A	Clear Space?	N/A
	Road X Slope (%)	3.1	N/A	Clear Space to XWalk (in)	N/A
N/A	Any Obstructions?	N/A	N/A	Storm Grate/Utility Hazard?	N/A
	Obstruction Type			Storm Grate/Utility Type	
		N/A			N/A
		Yes		Surface Condition? (G/P)	Good

Possible Solutions:

Remove & Replace Curb Ramp With Two New Directional Ramps or Equivalent.
