# Access Compliance Report

## Public Rights-of-Way

### (Curb Ramps)

Intersection ID: N/A	Main Street: ROCK_ISLAND_RD	Cross Street: AGNEW_DR	Location: SW
ADA ID: 60F0361B0899	Ramp Type: Perp	Initial Pass/Fail: Fail	Overall Compliance: No
Severity Score: 1.25			
Codes/Mitigation Info/Possible Solution		Field Measurements/Component Compliance

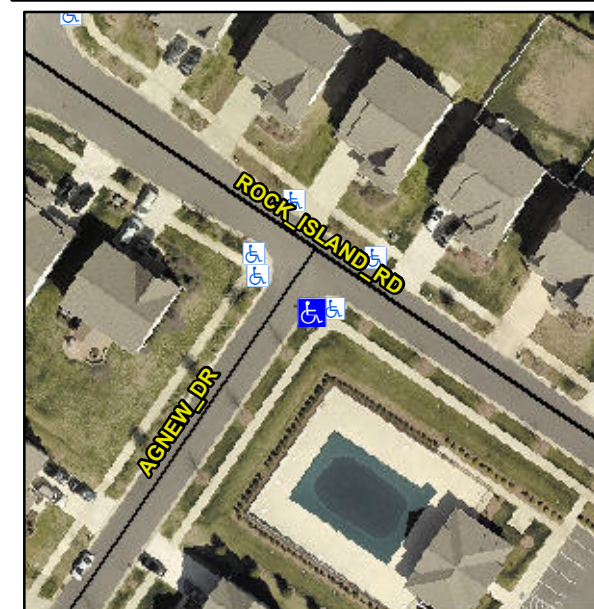
**Not Found, R304.5.3**

Compliance	Description	Data	Compliance	Description	Data
N/A	Ramp Length (in)	126.0	Yes	Ramp Slope (%)	7.6
Yes	Ramp Width (in)	48.0	No	Ramp XSlope (%)	2.9
N/A	Flare Type LT	N/A	N/A	Flare Type RT	N/A
N/A	Flare Slope LT (%)	N/A	N/A	Flare Slope RT (%)	N/A
N/A	Flare Traversable LT?	N/A	N/A	Flare Traversable RT?	N/A
N/A	Landing Length (in)	N/A	N/A	DWS Provided?	N/A
N/A	Landing Width (in)	N/A	N/A	DWS Contrast?	N/A
N/A	Landing Slope (%)	N/A	N/A	DWS Length (in)	N/A
N/A	Landing X Slope (%)	N/A	N/A	DWS Full Width?	N/A
N/A	Landing Curb? (Y/N)	N/A	N/A	DWS Offset (in)	N/A
N/A	Shared Landing?	N/A			
N/A	Gutter Ponding?	N/A	N/A	Gutter Slope (%)	N/A
N/A	Gutter Lip Ht (in)	N/A	N/A	Gutter X Slope (%)	N/A
N/A	Painted X Walk1?	No	N/A	Painted X Walk2?	N/A
	X Walk 1 Direction	To NW		X Walk 2 Direction	N/A
N/A	X Walk 1 Width (in)	N/A	N/A	X Walk 2 Width (in)	N/A
	X Walk 1 Slope (%)	3.8		X Walk 2 Slope (%)	N/A
	X Walk 1 X Slope (%)	0.1		X Walk 2 X Slope (%)	N/A

N/A	Ramp inside XWalk1?	N/A	N/A	Ramp inside XWalk2?	N/A
	Road Slope (%)	N/A	N/A	Clear Space?	N/A
	Road X Slope (%)	N/A	N/A	Clear Space to XWalk (in)	N/A
N/A	Any Obstructions?	N/A	N/A	Storm Grate/Utility Hazard?	N/A
	Obstruction Type			Storm Grate/Utility Type	
		N/A			N/A
		Yes		Surface Condition? (G/P)	Good

**Remove & Replace Entire Ramp.**

Total Cost: \$ 1850.00
