Access Compliance Report

Public Rights-of-Way

(Curb Ramps)

Intersection ID: N/A	Main Street: LANGWELL_LN	Cross Street: HAMILTON_BRIDGE_RD	Location: NE
ADA ID: 60F7B096D9EE	Ramp Type: Perp	Initial Pass/Fail: Fail	Overall Compliance: No
Codes/Mitigation Info/Possible Solution		Field Measurements/Component Compliance	
Severity Score: 33.75

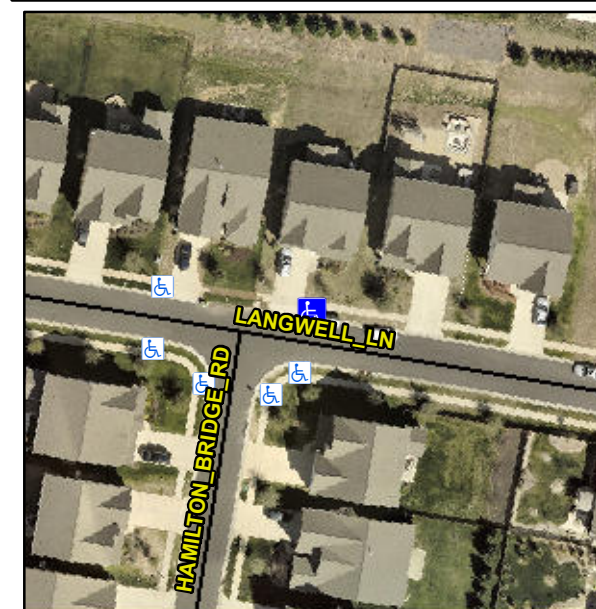
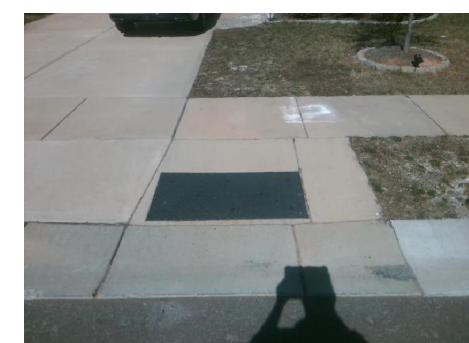
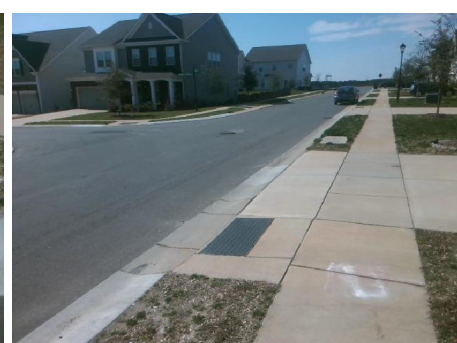
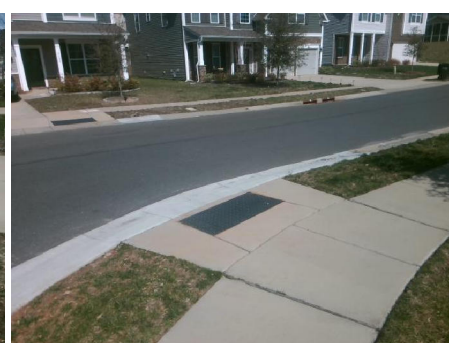
Not Found, R304.5.1, R304.2.2

Compliance	Description	Data	Compliance	Description	Data
N/A	Ramp Length (in)	47.0	No	Ramp Slope (%)	13.2
No	Ramp Width (in)	47.0	Yes	Ramp XSlope (%)	1.8
N/A	Flare Type LT	N/A	N/A	Flare Type RT	N/A
N/A	Flare Slope LT (%)	N/A	N/A	Flare Slope RT (%)	N/A
N/A	Flare Traversable LT?	N/A	N/A	Flare Traversable RT?	N/A
N/A	Landing Length (in)	N/A	N/A	DWS Provided?	N/A
N/A	Landing Width (in)	N/A	N/A	DWS Contrast?	N/A
N/A	Landing Slope (%)	N/A	N/A	DWS Length (in)	N/A
N/A	Landing X Slope (%)	N/A	N/A	DWS Full Width?	N/A
N/A	Landing Curb? (Y/N)	N/A	N/A	DWS Offset (in)	N/A
N/A	Shared Landing?	N/A			
N/A	Gutter Ponding?	N/A	N/A	Gutter Slope (%)	N/A
N/A	Gutter Lip Ht (in)	N/A	N/A	Gutter X Slope (%)	N/A
N/A	Painted X Walk1?	No	N/A	Painted X Walk2?	N/A
	X Walk 1 Direction	To SW		X Walk 2 Direction	N/A
N/A	X Walk 1 Width (in)	N/A	N/A	X Walk 2 Width (in)	N/A
	X Walk 1 Slope (%)	0.3		X Walk 2 Slope (%)	N/A
	X Walk 1 X Slope (%)	0.6		X Walk 2 X Slope (%)	N/A

N/A	Ramp inside XWalk1?	N/A	N/A	Ramp inside XWalk2?	N/A
	Road Slope (%)	N/A	N/A	Clear Space?	N/A
	Road X Slope (%)	N/A	N/A	Clear Space to XWalk (in)	N/A
N/A	Any Obstructions?	N/A	N/A	Storm Grate/Utility Hazard?	N/A
	Obstruction Type			Storm Grate/Utility Type	
		N/A			N/A
			Yes	Surface Condition? (G/P)	Good

Remove & Replace Entire Ramp.
