# Access Compliance Report

## Public Rights-of-Way

### (Curb Ramps)

Intersection ID: 3675	Main Street: DAVIS_LAKE_PY	Cross Street: ELK_RUN_LN	Location: S
ADA ID: 60F860E16CA7	Ramp Type: Perp	Initial Pass/Fail: Fail	Overall Compliance: No
Severity Score: 13.75			
Codes/Mitigation Info/Possible Solution		Field Measurements/Component Compliance

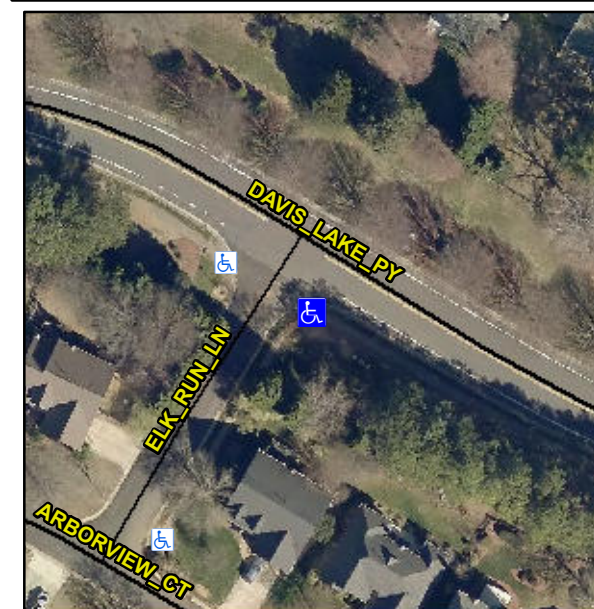
**Not Found, R304.2.2, R304.5.3**

Compliance	Description	Data	Compliance	Description	Data
N/A	Ramp Length (in)	50.0	No	Ramp Slope (%)	9.9
Yes	Ramp Width (in)	48.0	No	Ramp XSlope (%)	2.2
N/A	Flare Type LT	N/A	N/A	Flare Type RT	N/A
N/A	Flare Slope LT (%)	N/A	N/A	Flare Slope RT (%)	N/A
N/A	Flare Traversable LT?	N/A	N/A	Flare Traversable RT?	N/A
N/A	Landing Length (in)	N/A	N/A	DWS Provided?	N/A
N/A	Landing Width (in)	N/A	N/A	DWS Contrast?	N/A
N/A	Landing Slope (%)	N/A	N/A	DWS Length (in)	N/A
N/A	Landing X Slope (%)	N/A	N/A	DWS Full Width?	N/A
N/A	Landing Curb? (Y/N)	N/A	N/A	DWS Offset (in)	N/A
N/A	Shared Landing?	N/A			
N/A	Gutter Ponding?	N/A	N/A	Gutter Slope (%)	N/A
N/A	Gutter Lip Ht (in)	0.5	N/A	Gutter X Slope (%)	N/A
N/A	Painted X Walk1?	No	N/A	Painted X Walk2?	N/A
	X Walk 1 Direction	To NW		X Walk 2 Direction	N/A
N/A	X Walk 1 Width (in)	N/A	N/A	X Walk 2 Width (in)	N/A
	X Walk 1 Slope (%)	2.5		X Walk 2 Slope (%)	N/A
	X Walk 1 X Slope (%)	3.5		X Walk 2 X Slope (%)	N/A

N/A	Ramp inside XWalk1?	N/A	N/A	Ramp inside XWalk2?	N/A
	Road Slope (%)	N/A	N/A	Clear Space?	N/A
	Road X Slope (%)	N/A	N/A	Clear Space to XWalk (in)	N/A
N/A	Any Obstructions?	N/A	N/A	Storm Grate/Utility Hazard?	N/A
	Obstruction Type			Storm Grate/Utility Type	
		N/A			N/A
		Yes		Surface Condition? (G/P)	Good

**Remove & Replace Entire Ramp.**

Total Cost: \$ 1850.00
