Access Compliance Report

Public Rights-of-Way

(Curb Ramps)

Intersection ID: 11271	Main Street: CATAWBA_AV	Cross Street: PEGRAM_ST	Location: SW
ADA ID: 61000B1277C0	Ramp Type: Perp	Initial Pass/Fail: Fail	Overall Compliance: No
Severity Score: 13.75			
Codes/Mitigation Info/Possible Solution		Field Measurements/Component Compliance

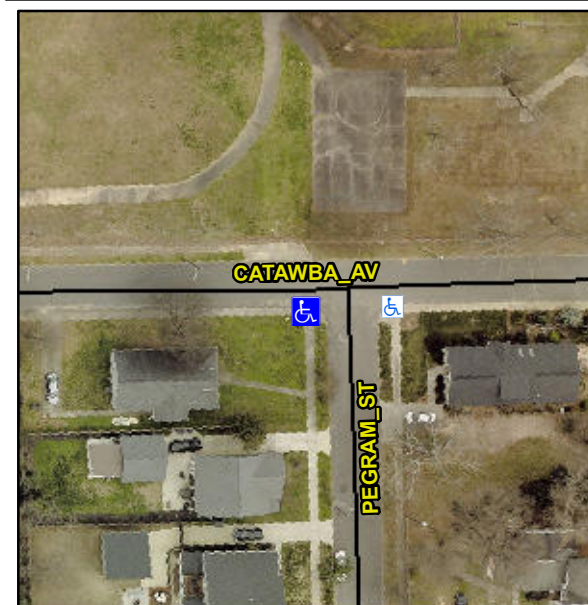
Not Found, R304.2.2, R304.5.3

Compliance	Description	Data	Compliance	Description	Data
N/A	Ramp Length (in)	64.0	No	Ramp Slope (%)	9.6
Yes	Ramp Width (in)	50.5	No	Ramp XSlope (%)	3.6
N/A	Flare Type LT	N/A	N/A	Flare Type RT	N/A
N/A	Flare Slope LT (%)	N/A	N/A	Flare Slope RT (%)	N/A
N/A	Flare Traversable LT?	N/A	N/A	Flare Traversable RT?	N/A
N/A	Landing Length (in)	N/A	N/A	DWS Provided?	N/A
N/A	Landing Width (in)	N/A	N/A	DWS Contrast?	N/A
N/A	Landing Slope (%)	N/A	N/A	DWS Length (in)	N/A
N/A	Landing X Slope (%)	N/A	N/A	DWS Full Width?	N/A
N/A	Landing Curb? (Y/N)	N/A	N/A	DWS Offset (in)	N/A
N/A	Shared Landing?	N/A			
N/A	Gutter Ponding?	N/A	N/A	Gutter Slope (%)	N/A
N/A	Gutter Lip Ht (in)	0.5	N/A	Gutter X Slope (%)	N/A
N/A	Painted X Walk1?	No	N/A	Painted X Walk2?	N/A
	X Walk 1 Direction	To E		X Walk 2 Direction	N/A
N/A	X Walk 1 Width (in)	N/A	N/A	X Walk 2 Width (in)	N/A
	X Walk 1 Slope (%)	5.6		X Walk 2 Slope (%)	N/A
	X Walk 1 X Slope (%)	3.9		X Walk 2 X Slope (%)	N/A

N/A	Ramp inside XWalk1?	N/A	N/A	Ramp inside XWalk2?	N/A
	Road Slope (%)	N/A	N/A	Clear Space?	N/A
	Road X Slope (%)	N/A	N/A	Clear Space to XWalk (in)	N/A
N/A	Any Obstructions?	N/A	N/A	Storm Grate/Utility Hazard?	N/A
	Obstruction Type			Storm Grate/Utility Type	
		N/A			N/A
			Yes	Surface Condition? (G/P)	Good

Possible Solutions:

Remove & Replace Entire Ramp.

Total Cost: \$ 1850.00
