Access Compliance Report

Public Rights-of-Way

(Curb Ramps)

Intersection ID: 12618	Main Street: E_5TH_ST	Cross Street: N_CALDWELL_ST	Location: S
ADA ID: 612AE55DD7CD	Ramp Type: Perp	Initial Pass/Fail: Fail	Overall Compliance: No
Severity Score: 10			
Codes/Mitigation Info/Possible Solution		Field Measurements/Component Compliance

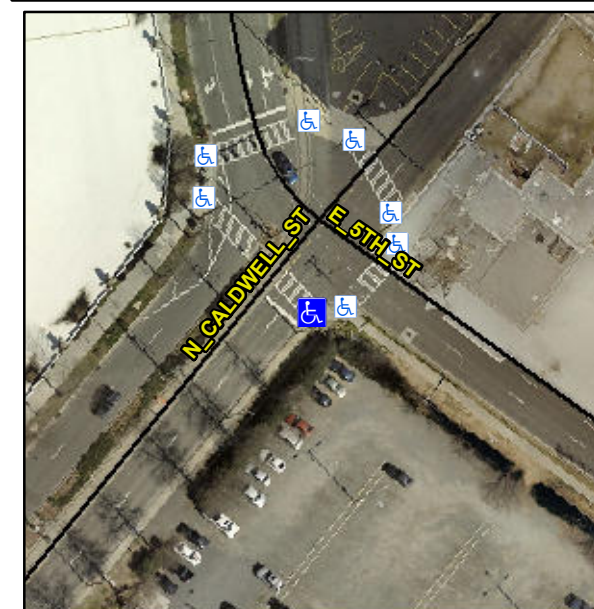
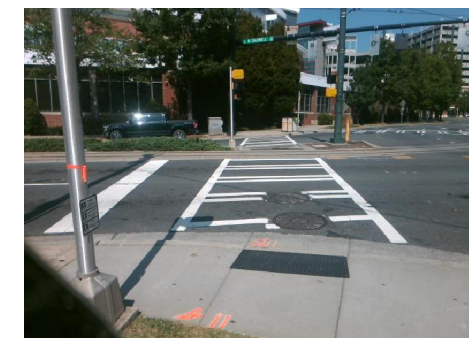
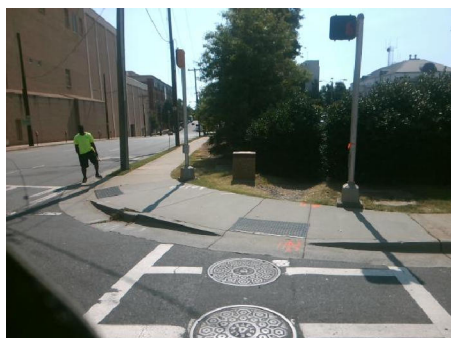
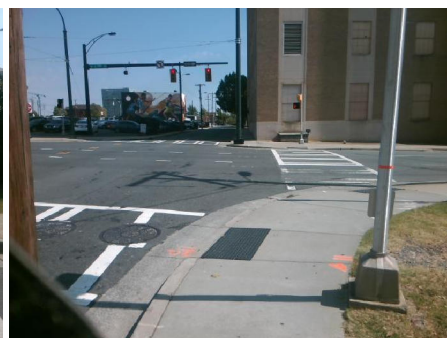
Not Found, R304.5.1, R304.5.3

Compliance	Description	Data	Compliance	Description	Data
N/A	Ramp Length (in)	73.0	Yes	Ramp Slope (%)	6.3
No	Ramp Width (in)	38.0	No	Ramp XSlope (%)	2.7
N/A	Flare Type LT	N/A	N/A	Flare Type RT	N/A
N/A	Flare Slope LT (%)	N/A	N/A	Flare Slope RT (%)	N/A
N/A	Flare Traversable LT?	N/A	N/A	Flare Traversable RT?	N/A
N/A	Landing Length (in)	N/A	N/A	DWS Provided?	N/A
N/A	Landing Width (in)	N/A	N/A	DWS Contrast?	N/A
N/A	Landing Slope (%)	N/A	N/A	DWS Length (in)	N/A
N/A	Landing X Slope (%)	N/A	N/A	DWS Full Width?	N/A
N/A	Landing Curb? (Y/N)	N/A	N/A	DWS Offset (in)	N/A
N/A	Shared Landing?	N/A			
N/A	Gutter Ponding?	N/A	N/A	Gutter Slope (%)	N/A
N/A	Gutter Lip Ht (in)	N/A	N/A	Gutter X Slope (%)	N/A
N/A	Painted X Walk1?	Yes	N/A	Painted X Walk2?	N/A
	X Walk 1 Direction	To NW		X Walk 2 Direction	N/A
N/A	X Walk 1 Width (in)	113.0	N/A	X Walk 2 Width (in)	N/A
	X Walk 1 Slope (%)	7.4		X Walk 2 Slope (%)	N/A
	X Walk 1 X Slope (%)	1.8		X Walk 2 X Slope (%)	N/A

N/A	Ramp inside XWalk1?	Yes	N/A	Ramp inside XWalk2?	N/A
	Road Slope (%)	N/A	N/A	Clear Space?	N/A
	Road X Slope (%)	N/A	N/A	Clear Space to XWalk (in)	N/A
N/A	Any Obstructions?	N/A	N/A	Storm Grate/Utility Hazard?	N/A
	Obstruction Type			Storm Grate/Utility Type	
		N/A			N/A
		Yes		Surface Condition? (G/P)	Good

Remove & Replace Entire Ramp.
