Access Compliance Report

Public Rights-of-Way

(Curb Ramps)

| Intersection ID: 26470 | Main Street: THORNBUSH_CT | Cross Street: WINTHROP_RIDGE_RD | Location: SW |

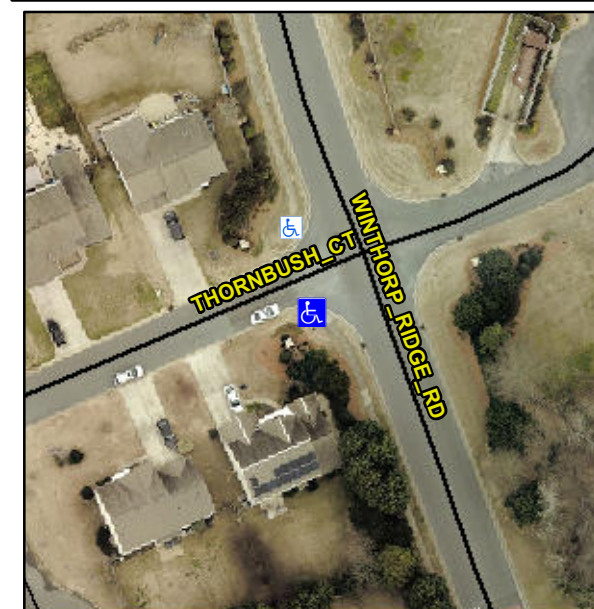
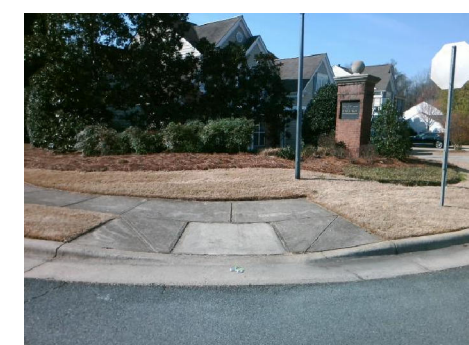
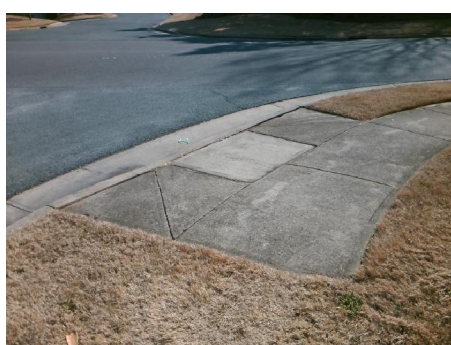
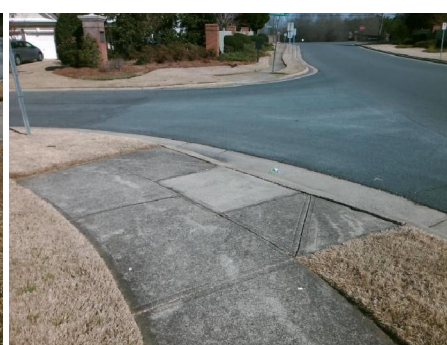
Not Found, R304.2.2

| Compliance | Description | Data | Compliance | Description | Data |
|---|---|---|---|---|---|
| N/A | Ramp Length (in) | 96.0 | No | Ramp Slope (%) | 9.9 |

Remove & Replace Entire Ramp.
