Access Compliance Report Public Rights-of-Way (Curb Ramps)

Intersection ID: 29183 Main Street: JADE GLEN DR Cross Street: GARRISON_RD Location: S ADA ID: 6134580BC778 Ramp Type: PerpDiag Initial Pass/Fail: Fail **Overall Compliance: No Severity Score:** 10

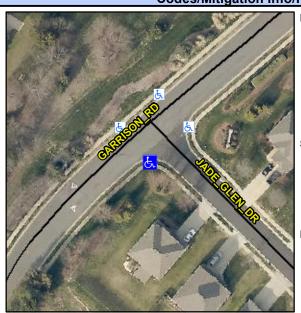
Field Measurements/Component Compliance							
	Compliance Description		Data	Compliance Description		Data	
	N/A	Ramp Length (in)	48.0	Yes	Ramp	Slope (%)	5.7
	No	Ramp Width (in)	44.5	No	Ramp	XSlope (%)	2.2
	N/A	Flare Type LT	N/A	N/A	Flare	Гуре RT	N/A
	N/A	Flare Slope LT (%)	N/A	N/A	Flare	Slope RT (%)	N/A
	N/A	Flare Traversable LT?	N/A	N/A	Flare	Traversable RT?	N/A
	N/A	Landing Length (in)	N/A	N/A	DWS I	Provided?	N/A
	N/A	Landing Width (in)	N/A	N/A	DWS (Contrast?	N/A
	N/A	Landing Slope (%)	N/A	N/A	DWS I	_ength (in)	N/A
	N/A	Landing X Slope (%)	N/A	N/A	DWS I	Full Width?	N/A
	N/A	Landing Curb? (Y/N)	N/A	N/A	DWS (Offset (in)	N/A
	N/A	Shared Landing?	N/A				
	N/A	Gutter Ponding?	N/A	N/A	Gutter	Slope (%)	N/A
	N/A	Gutter Lip Ht (in)	N/A	N/A	Gutter	X Slope (%)	N/A
	N/A	Painted X Walk1?	No	N/A	Painte	d X Walk2?	No
		X Walk 1 Direction	To NE		X Wall	c 2 Direction	To NW
	N/A	X Walk 1 Width (in)	N/A	N/A	X Wall	< 2 Width (in)	N/A

X Walk 1 Slope (%)	0.9		X Wall	< 2 Slope (%)	5.6
		X Walk 1 X Slope (%)	3.7		X Wall	< 2 X Slope (%)	0.1
	N/A	Ramp inside XWalk1?	N/A	N/A	Ramp	inside XWalk2?	N/A
		Road Slope (%)	2.4	N/A	Clear	Space?	N/A
		Road X Slope (%)	3.0	N/A	Clear	Space to XWalk (in)	N/A
	N/A	Any Obstructions?	N/A	N/A	Storm	Grate/Utility Hazard?	N/A
		Obstruction Type			Storm	Grate/Utility Type	
			N/A				N/A
				Yes	Surfac	e Condition? (G/P)	Good
36	10.8

Possible Solutions: Remove & Replace Curb Ramp With Two New Directional Ramps or Equivalent. Surveyor Notes: N/A PROW/ADA: Not Found, R304.5.1, R304.5.3
