Access Compliance Report

Public Rights-of-Way

(Curb Ramps)

Intersection ID: 14843	Main Street: LYNDHURST_AV	Cross Street: MEACHAM_ST	Location: S
ADA ID: 613579B79B24	Ramp Type: BlendTrans1	Initial Pass/Fail: Fail	Overall Compliance: No
Severity Score: 8.75			
Codes/Mitigation Info/Possible Solution		Field Measurements/Component Compliance

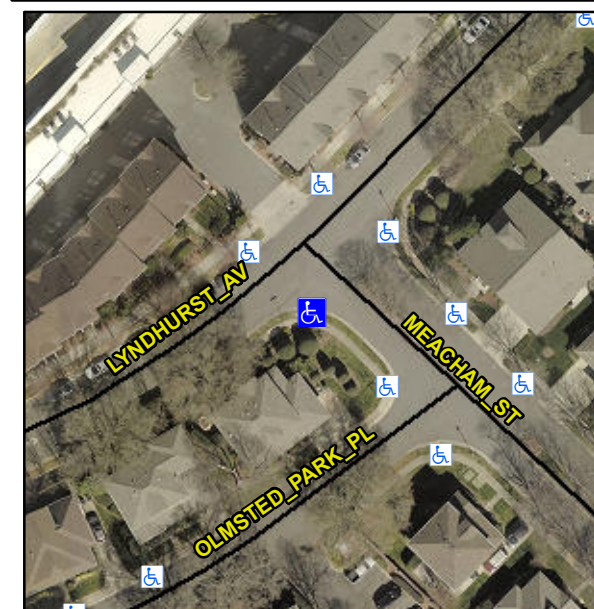
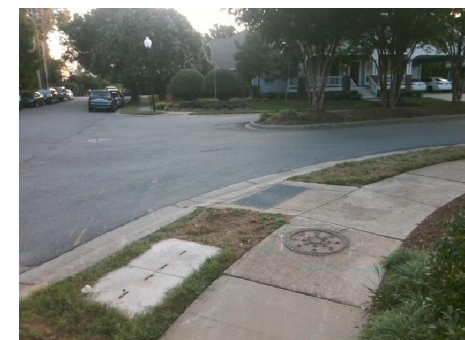
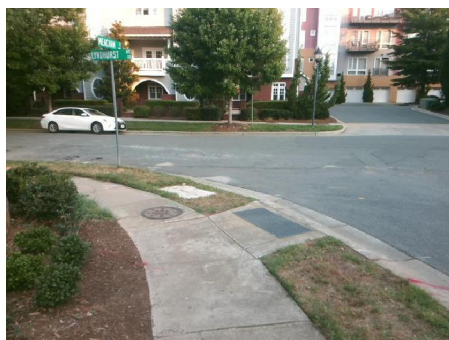
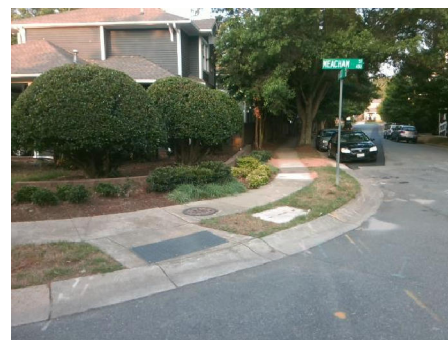
Not Found, R304.5.1

Compliance	Description	Data	Compliance	Description	Data
N/A	Ramp Length (in)	50.0	Yes	BlendTrans Slope (%)	2.3
No	Ramp Width (in)	43.0	Yes	BlendTrans XSlope (%)	1.5
N/A	Flare Type LT	N/A	N/A	Flare Type RT	N/A
N/A	Flare Slope LT (%)	N/A	N/A	Flare Slope RT (%)	N/A
N/A	Flare Traversable LT?	N/A	N/A	Flare Traversable RT?	N/A
N/A	Landing Length (in)	N/A	N/A	DWS Provided?	N/A
N/A	Landing Width (in)	N/A	N/A	DWS Contrast?	N/A
N/A	Landing Slope (%)	N/A	N/A	DWS Length (in)	N/A
N/A	Landing X Slope (%)	N/A	N/A	DWS Full Width?	N/A
N/A	Landing Curb? (Y/N)	N/A	N/A	DWS Offset (in)	N/A
N/A	Shared Landing?	N/A			
N/A	Gutter Ponding?	N/A	N/A	Gutter Slope (%)	N/A
N/A	Gutter Lip Ht (in)	N/A	N/A	Gutter X Slope (%)	N/A
N/A	Painted X Walk1?	No	N/A	Painted X Walk2?	No
	X Walk 1 Direction	To NE		X Walk 2 Direction	To NW
	X Walk 1 Width (in)	N/A		X Walk 2 Width (in)	N/A
	X Walk 1 Slope (%)	3.2		X Walk 2 Slope (%)	1.7
	X Walk 1 X Slope (%)	0.9		X Walk 2 X Slope (%)	2.8

N/A	Ramp inside XWalk1?	N/A	N/A	Ramp inside XWalk2?	N/A
	Road Slope (%)	0.8		Clear Space?	N/A
	Road X Slope (%)	2.1	N/A	Clear Space to XWalk (in)	N/A
N/A	Any Obstructions?	N/A	N/A	Storm Grate/Utility Hazard?	N/A
	Obstruction Type			Storm Grate/Utility Type	
		N/A			N/A
			Yes	Surface Condition? (G/P)	Good
			No	Curb Slope (%)	17.9

Remove & Replace Curb Ramp With Two New Directional Ramps or Equivalent.
