Access Compliance Report

Public Rights-of-Way

(Curb Ramps)

Intersection ID: 16077	Main Street: ELLENWOOD_PL	Cross Street: YORKSHIRE_DR	Location: SW
ADA ID: 613BAC4BD4D2	Ramp Type: PerpDiag	Initial Pass/Fail: Fail	Overall Compliance: No
Severity Score: 12.5			
Codes/Mitigation Info/Possible Solution		Field Measurements/Component Compliance

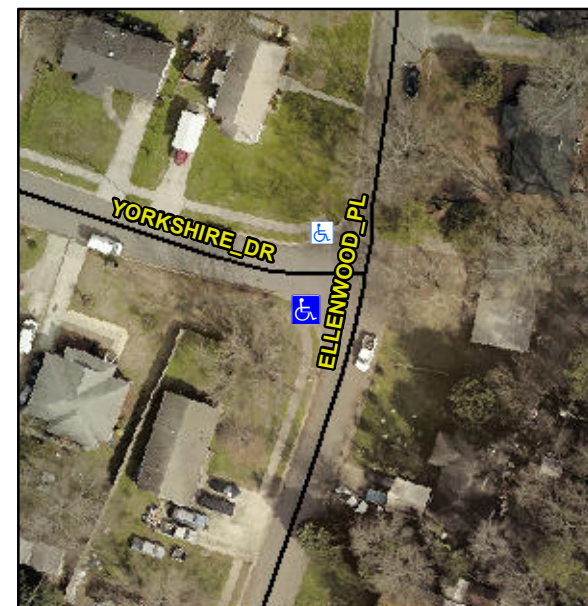
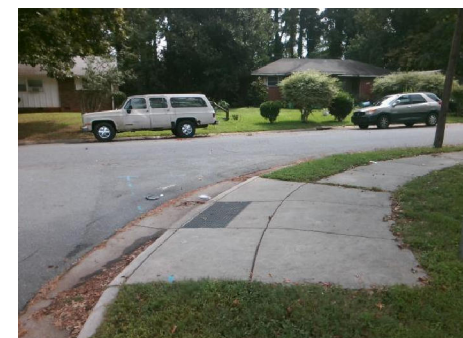
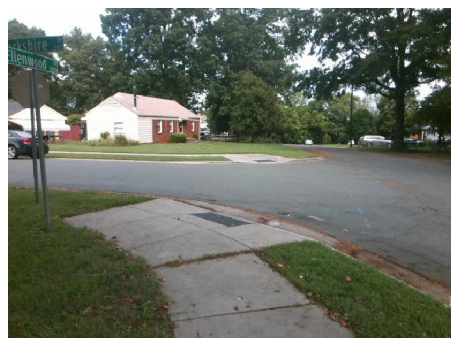
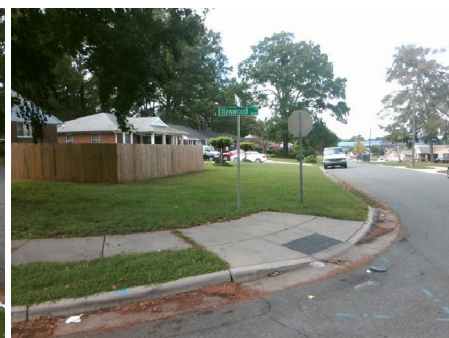
Not Found, R304.2.2

Compliance	Description	Data	Compliance	Description	Data
N/A	Ramp Length (in)	46.0	No	Ramp Slope (%)	11.4
Yes	Ramp Width (in)	48.0	Yes	Ramp XSlope (%)	0.7
N/A	Flare Type LT	N/A	N/A	Flare Type RT	N/A
N/A	Flare Slope LT (%)	N/A	N/A	Flare Slope RT (%)	N/A
N/A	Flare Traversable LT?	N/A	N/A	Flare Traversable RT?	N/A
N/A	Landing Length (in)	N/A	N/A	DWS Provided?	N/A
N/A	Landing Width (in)	N/A	N/A	DWS Contrast?	N/A
N/A	Landing Slope (%)	N/A	N/A	DWS Length (in)	N/A
N/A	Landing X Slope (%)	N/A	N/A	DWS Full Width?	N/A
N/A	Landing Curb? (Y/N)	N/A	N/A	DWS Offset (in)	N/A
N/A	Shared Landing?	N/A			
N/A	Gutter Ponding?	N/A	N/A	Gutter Slope (%)	N/A
N/A	Gutter Lip Ht (in)	N/A	N/A	Gutter X Slope (%)	N/A
N/A	Painted X Walk1?	No	N/A	Painted X Walk2?	No
	X Walk 1 Direction	To E		X Walk 2 Direction	To N
N/A	X Walk 1 Width (in)	N/A	N/A	X Walk 2 Width (in)	N/A
	X Walk 1 Slope (%)	3.3		X Walk 2 Slope (%)	4.1
	X Walk 1 X Slope (%)	0.7		X Walk 2 X Slope (%)	0.5

N/A	Ramp inside XWalk1?	N/A	N/A	Ramp inside XWalk2?	N/A
	Road Slope (%)	0.3	N/A	Clear Space?	N/A
	Road X Slope (%)	5.1	N/A	Clear Space to XWalk (in)	N/A
N/A	Any Obstructions?	N/A	N/A	Storm Grate/Utility Hazard?	N/A
	Obstruction Type			Storm Grate/Utility Type	
		N/A			N/A
			Yes	Surface Condition? (G/P)	Good

Possible Solutions:

Remove & Replace Curb Ramp With Two New Directional Ramps or Equivalent.

Total Cost: \$ **3200.00**
