Access Compliance Report Public Rights-of-Way (Curb Ramps)

Intersection ID: 30066 Main Street: DAY LILLY LN **Cross Street: SUNSET RD** Location: NW **Overall Compliance: No** ADA ID: 613DC34AFF2F Ramp Type: Perp Initial Pass/Fail: Fail **Severity Score:** 22.5

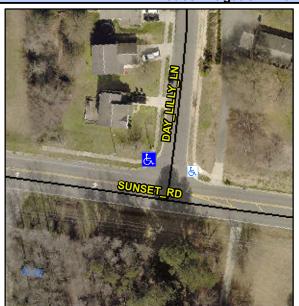
N/A	Ramp Length (in)	47.0	No	Ramp Slope (%)	8.5
No	Ramp Width (in)	38.5	No	Ramp XSlope (%)	4.6
N/A	Flare Type LT	N/A	N/A	Flare Type RT	N/A
N/A	Flare Slope LT (%)	N/A	N/A	Flare Slope RT (%)	N/A
N/A	Flare Traversable LT?	N/A	N/A	Flare Traversable RT?	N/A
N/A	Landing Length (in)	N/A	N/A	DWS Provided?	N/A
N/A	Landing Width (in)	N/A	N/A	DWS Contrast?	N/A
N/A	Landing Slope (%)	N/A	N/A	DWS Length (in)	N/A
N/A	Landing X Slope (%)	N/A	N/A	DWS Full Width?	N/A
N/A	Landing Curb? (Y/N)	N/A	N/A	DWS Offset (in)	N/A
N/A	Shared Landing?	N/A			
N/A	Gutter Ponding?	Yes	N/A	Gutter Slope (%)	N/A
N/A	Gutter Lip Ht (in)	N/A	N/A	Gutter X Slope (%)	N/A
N/A	Painted X Walk1?	No	N/A	Painted X Walk2?	N/A
	X Walk 1 Direction	To SE		X Walk 2 Direction	N/A
N/A	X Walk 1 Width (in)	N/A	N/A	X Walk 2 Width (in)	N/A
	X Walk 1 Slope (%)	2.2		X Walk 2 Slope (%)	N/A
	X Walk 1 X Slope (%)	1.6		X Walk 2 X Slope (%)	N/A
N/A	Ramp inside XWalk1?	N/A	N/A	Ramp inside XWalk2?	N/A

Road Slope (%)	N/A	N/A	Clear Space?	N/A
	Road X Slope (%)	N/A	N/A	Clear Space to XWalk (in)	N/A
N/A	Any Obstructions?	N/A	N/A	Storm Grate/Utility Hazard?	N/A
	Obstruction Type			Storm Grate/Utility Type	
		N/A			N/A
			Yes	Surface Condition? (G/P)	Good

Possible Solutions:
Remove & Replace Entire Ramp.
·
Surveyor Notes:
N/A
PROW/ADA:
Not Found, R304.5.1, R304.2.2,
R304.5.3

PROW/ADA:			
Not Found, R304.5.3	R304.5.1, R304		
Total Cost:	:	\$	1850.00
