Access Compliance Report Public Rights-of-Way (Curb Ramps)

Intersection ID: 18011 Main Street: PARK RD **Cross Street: HEATHER LN** Location: NE Ramp Type: Perp Initial Pass/Fail: Fail **Overall Compliance: No** Severity Score: 21.25 **ADA ID: 613F372562EF**

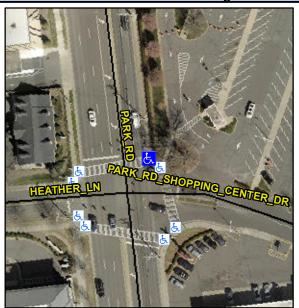
Possible Solutions:	Comp	liance Description	Data	Compl	iance Description
Remove & Replace Entire Ramp.	N/A	Ramp Length (in)	60.0	Yes	Ramp Slope (%)
	No	Ramp Width (in)	47.5	No	Ramp XSlope (%)
	N/A	Flare Type LT	N/A	N/A	Flare Type RT
f	N/A	Flare Slope LT (%)	N/A	N/A	Flare Slope RT (%)
1	N/A	Flare Traversable LT?	N/A	N/A	Flare Traversable R
	N/A	Landing Length (in)	N/A	N/A	DWS Provided?
Surveyor Notes:	N/A	Landing Width (in)	N/A	N/A	DWS Contrast?
N/A	N/A	Landing Slope (%)	N/A	N/A	DWS Length (in)
	N/A	Landing X Slope (%)	N/A	N/A	DWS Full Width?
	N/A	Landing Curb? (Y/N)	N/A	N/A	DWS Offset (in)
	N/A	Shared Landing?	N/A		
PROW/ADA:	N/A	Gutter Ponding?	N/A	N/A	Gutter Slope (%)
Not Found, R304.5.1, R304.5.3	N/A	Gutter Lip Ht (in)	N/A	N/A	Gutter X Slope (%)
,	N/A	Painted X Walk1?	Yes	N/A	Painted X Walk2?
		X Walk 1 Direction	To W		X Walk 2 Direction
	N/A	X Walk 1 Width (in)	106.0	N/A	X Walk 2 Width (in)
		X Walk 1 Slope (%)	1.5		X Walk 2 Slope (%)

X Walk 1 X Slope (%)	2.4		X Walk 2 X Slope (%
	N/A	Ramp inside XWalk1?	Yes	N/A	Ramp inside XWalk2
		Road Slope (%)	N/A	N/A	Clear Space?
		Road X Slope (%)	N/A	N/A	Clear Space to XWa
	N/A	Any Obstructions?	N/A	N/A	Storm Grate/Utility H
