Access Compliance Report

Public Rights-of-Way

(Curb Ramps)

Intersection ID: N/A	Main Street: BROOKVALE_ST	Cross Street: HORACE_ST	Location: SW
ADA ID: 614004116F67	Ramp Type: Perp	Initial Pass/Fail: Fail	Overall Compliance: No
		Severity Score: 12.5

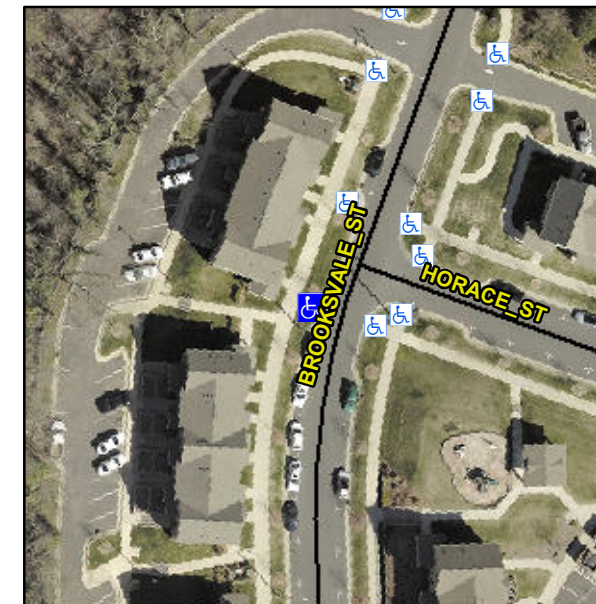
Compliance	Description	Data	Compliance	Description	Data
N/A	Ramp Length (in)	72.0	No	Ramp Slope (%)	8.7
Yes	Ramp Width (in)	70.0	Yes	Ramp XSlope (%)	1.0
N/A	Flare Type LT	N/A	N/A	Flare Type RT	N/A
N/A	Flare Slope LT (%)	N/A	N/A	Flare Slope RT (%)	N/A
N/A	Flare Traversable LT?	N/A	N/A	Flare Traversable RT?	N/A
N/A	Landing Length (in)	N/A	N/A	DWS Provided?	N/A
N/A	Landing Width (in)	N/A	N/A	DWS Contrast?	N/A
N/A	Landing Slope (%)	N/A	N/A	DWS Length (in)	N/A
N/A	Landing X Slope (%)	N/A	N/A	DWS Full Width?	N/A
N/A	Landing Curb? (Y/N)	N/A	N/A	DWS Offset (in)	N/A
N/A	Shared Landing?	N/A			
N/A	Gutter Ponding?	N/A	N/A	Gutter Slope (%)	N/A
N/A	Gutter Lip Ht (in)	N/A	N/A	Gutter X Slope (%)	N/A
N/A	Painted X Walk1?	No	N/A	Painted X Walk2?	N/A
	X Walk 1 Direction	To SE		X Walk 2 Direction	N/A
N/A	X Walk 1 Width (in)	N/A	N/A	X Walk 2 Width (in)	N/A
	X Walk 1 Slope (%)	2.2		X Walk 2 Slope (%)	N/A
	X Walk 1 X Slope (%)	0.4		X Walk 2 X Slope (%)	N/A

N/A	Ramp inside XWalk1?	N/A	N/A	Ramp inside XWalk2?	N/A
	Road Slope (%)	N/A	N/A	Clear Space?	N/A
	Road X Slope (%)	N/A	N/A	Clear Space to XWalk (in)	N/A
N/A	Any Obstructions?	N/A	N/A	Storm Grate/Utility Hazard?	N/A
	Obstruction Type			Storm Grate/Utility Type	
		N/A			N/A
			Yes	Surface Condition? (G/P)	Good

Remove & Replace Entire Ramp.
