Intersection ID: 17899	Main Street: STACY_BV	Cross Street: GARRIS_RD	Location:	NW
ADA ID: 61499A78ACA8	Ramp Type: Perp	Initial Pass/Fail: Fail	Overall Compliance: No	Severity Score: 1.25

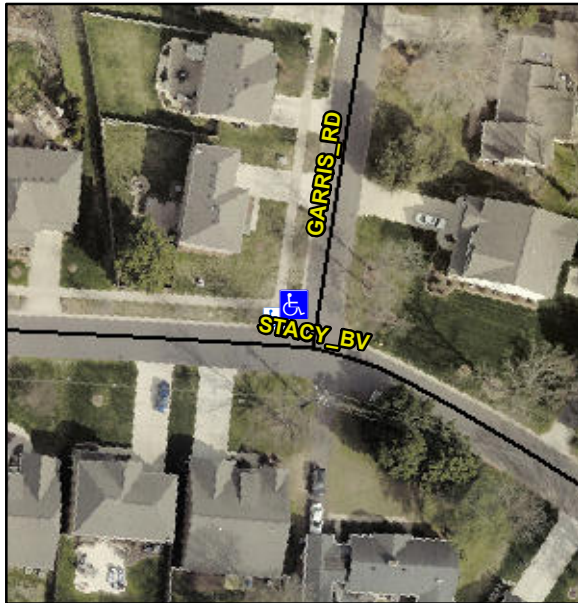
Not Found, R304.5.3

Possible Solutions:			Compliance	Description	Data	Compliance	Description	Data
Remove & Replace Entire Ramp.			N/A	Ramp Length (in)	94.0	Yes	Ramp Slope (%)	7.4
			Yes	Ramp Width (in)	48.0	No	Ramp XSlope (%)	3.6
			N/A	Flare Type LT	N/A	N/A	Flare Type RT	N/A
			N/A	Flare Slope LT (%)	N/A	N/A	Flare Slope RT (%)	N/A
			N/A	Flare Traversable LT?	N/A	N/A	Flare Traversable RT?	N/A
			N/A	Landing Length (in)	N/A	N/A	DWS Provided?	N/A
			N/A	Landing Width (in)	N/A	N/A	DWS Contrast?	N/A
			N/A	Landing Slope (%)	N/A	N/A	DWS Length (in)	N/A
			N/A	Landing X Slope (%)	N/A	N/A	DWS Full Width?	N/A
			N/A	Landing Curb? (Y/N)	N/A	N/A	DWS Offset (in)	N/A
			N/A	Shared Landing?	N/A			
			N/A	Gutter Ponding?	N/A	N/A	Gutter Slope (%)	N/A
Surveyor Notes: N/A			N/A	Gutter Lip Ht (in)	N/A	N/A	Gutter X Slope (%)	N/A
			N/A	Painted X Walk1?	No	N/A	Painted X Walk2?	N/A
				X Walk 1 Direction	To E		X Walk 2 Direction	N/A
			N/A	X Walk 1 Width (in)	N/A	N/A	X Walk 2 Width (in)	N/A

Remove & Replace Entire Ramp.
