## **Access Compliance Report Public Rights-of-Way** (Curb Ramps)

Intersection ID: 10033074 Main Street: NORTH\_COMMUNITY\_HOUSE\_Ross Street: N/A Location: NE

ADA ID: 614ADF018B64 Ramp Type: PerpDiag Initial Pass/Fail: Fail **Overall Compliance: No** Severity Score: 33.75

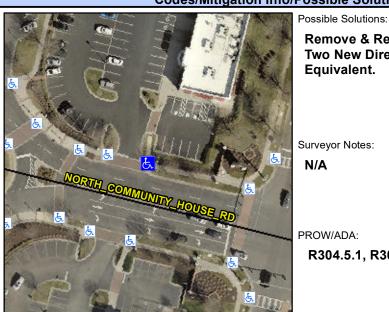
**ENTRANCE** Street 1 Name Stop Condition-Street 2 StopSign Street 2 Name **COMMUNITY HOUSE RD** Stop Condition-Street 1 YieldSign

Field Measurements/Component Compliance						
	Compliance Description		Data	Comp	liance Description	Data
	N/A	Ramp Length (in)	143.0	Yes	Ramp Slope (%)	5.2
	No	Ramp Width (in)	41.0	No	Ramp XSlope (%)	7.9
	N/A	Flare Type LT	N/A	N/A	Flare Type RT	N/A
	N/A	Flare Slope LT (%)	N/A	N/A	Flare Slope RT (%)	N/A
	N/A	Flare Traversable LT?	N/A	N/A	Flare Traversable RT?	N/A
	N/A	Landing Length (in)	N/A	N/A	DWS Provided?	N/A
	N/A	Landing Width (in)	N/A	N/A	DWS Contrast?	N/A
	N/A	Landing Slope (%)	N/A	N/A	DWS Length (in)	N/A
	N/A	Landing X Slope (%)	N/A	N/A	DWS Full Width?	N/A
	N/A	Landing Curb? (Y/N)	N/A	N/A	DWS Offset (in)	N/A
	N/A	Shared Landing?	N/A			
	N/A	Gutter Ponding?	N/A	N/A	Gutter Slope (%)	N/A
	N/A	Gutter Lip Ht (in)	N/A	N/A	Gutter X Slope (%)	N/A
	N/A	Painted X Walk1?	Yes	N/A	Painted X Walk2?	No
		X Walk 1 Direction	To W		X Walk 2 Direction	To S
	N/A	X Walk 1 Width (in)	120.0	N/A	X Walk 2 Width (in)	N/A
		X Walk 1 Slope (%)	2.8		X Walk 2 Slope (%)	3.8

X Walk 1 X Slope (%)	3.6		X Walk 2 X Slope (%)	4.8
	N/A	Ramp inside XWalk1?	Yes	N/A	Ramp inside XWalk2?	N/A
		Road Slope (%)	4.5	N/A	Clear Space?	N/A
		Road X Slope (%)	0.5	N/A	Clear Space to XWalk (in)	N/A
	N/A	Any Obstructions?	N/A	N/A	Storm Grate/Utility Hazard?	N/A
		Obstruction Type			Storm Grate/Utility Type	
			N/A			N/A
				Yes	Surface Condition? (G/P)	Good

Remove & Replace Curb Ramp With Two New Directional Ramps or Equivalent.

R304.5.1, R304.5.3
