# Access Compliance Report

## Public Rights-of-Way

| Intersection ID: 49249 | Main Street: BOOMERANG_WY | Cross Street: PROSPERITY_VIEW_DR | Location: NW |
| ADA ID: 615450D2BB22 | Ramp Type: BlendTrans1 | Initial Pass/Fail: Pass | Overall Compliance: No |

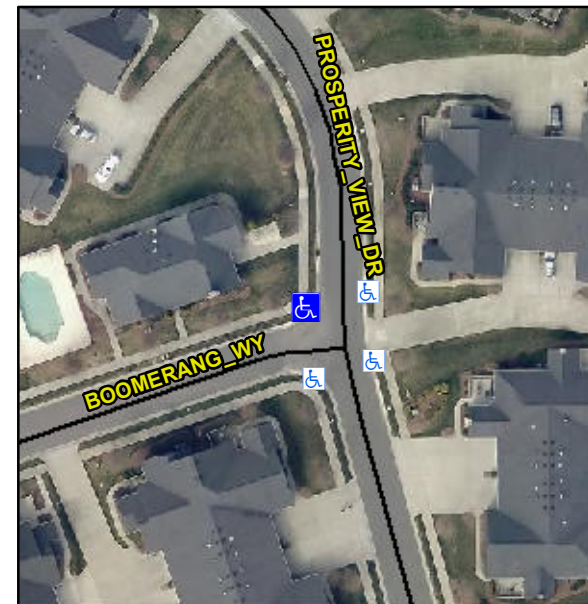
**Not Found, R305.2, R302.7, R302.7.2, R304.5.4, R304.5.3**

| Compliance | Description | Data | Compliance | Description | Data |
|---|---|---|---|---|---|
| No | Gutter Ponding? | Yes | No | Gutter Slope (%) | 7.3 |
| No | Gutter Lip Ht (in) | 1.5 | No | Gutter X Slope (%) | 5.0 |

**Remove & Replace Curb Ramp With Two New Directional Ramps or Equivalent. Remove & Replace Gutter.**

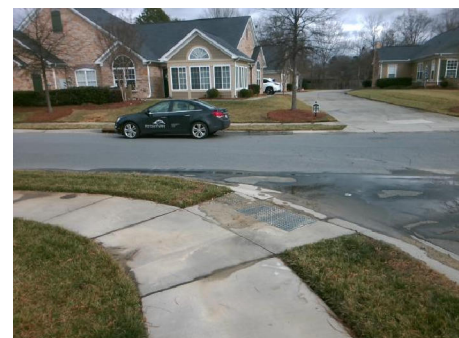
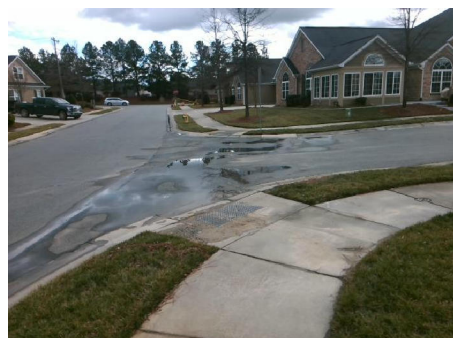
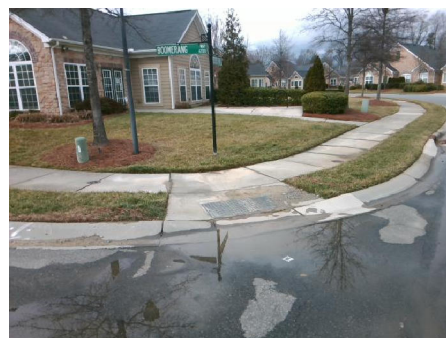
| Compliance | Description | Data | Compliance | Description | Data |
|---|---|---|---|---|---|
| | | | No | Curb Slope (%) | 6.2 |
