# Access Compliance Report

## Public Rights-of-Way

### (Curb Ramps)

Intersection ID: 11514	Main Street: E_20TH_ST	Cross Street: N_MCDOWELL_ST	Location: S
ADA ID: 615D70259B7D	Ramp Type: Perp	Initial Pass/Fail: Fail	Overall Compliance: No
		Severity Score: 67.5

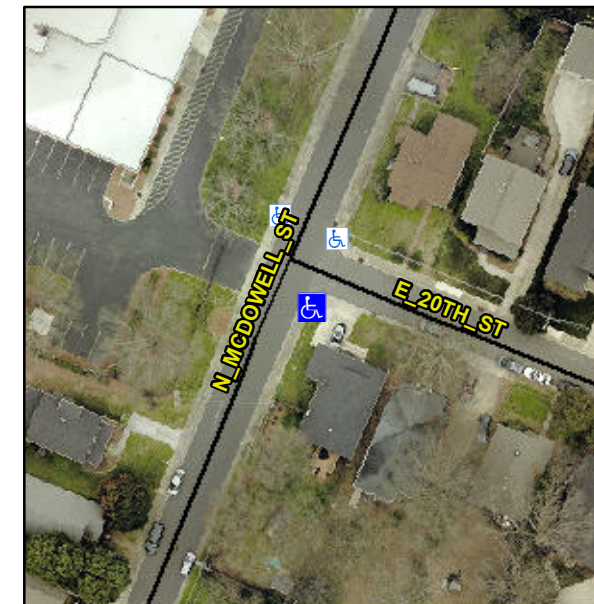
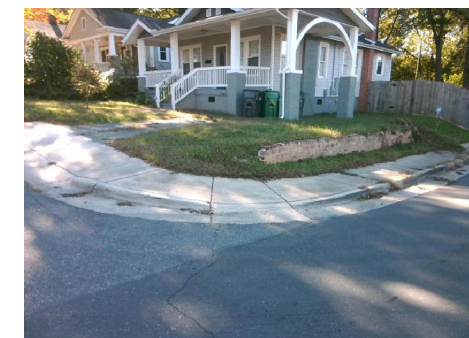
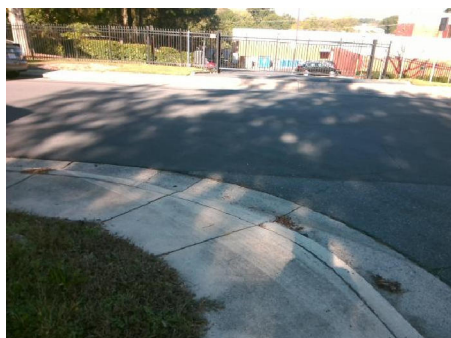
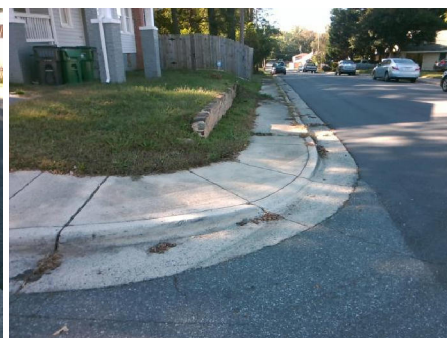
**Not Found, R304.5.1, R304.2.2, R304.5.3**

Compliance	Description	Data	Compliance	Description	Data
N/A	Ramp Length (in)	48.0	No	Ramp Slope (%)	12.9
No	Ramp Width (in)	33.5	No	Ramp XSlope (%)	8.9
N/A	Flare Type LT	N/A	N/A	Flare Type RT	N/A
N/A	Flare Slope LT (%)	N/A	N/A	Flare Slope RT (%)	N/A
N/A	Flare Traversable LT?	N/A	N/A	Flare Traversable RT?	N/A
N/A	Landing Length (in)	N/A	N/A	DWS Provided?	N/A
N/A	Landing Width (in)	N/A	N/A	DWS Contrast?	N/A
N/A	Landing Slope (%)	N/A	N/A	DWS Length (in)	N/A
N/A	Landing X Slope (%)	N/A	N/A	DWS Full Width?	N/A
N/A	Landing Curb? (Y/N)	N/A	N/A	DWS Offset (in)	N/A
N/A	Shared Landing?	N/A			
N/A	Gutter Ponding?	N/A	N/A	Gutter Slope (%)	N/A
N/A	Gutter Lip Ht (in)	N/A	N/A	Gutter X Slope (%)	N/A
N/A	Painted X Walk1?	No	N/A	Painted X Walk2?	N/A
	X Walk 1 Direction	To NE		X Walk 2 Direction	N/A
N/A	X Walk 1 Width (in)	N/A	N/A	X Walk 2 Width (in)	N/A
	X Walk 1 Slope (%)	6.0		X Walk 2 Slope (%)	N/A
	X Walk 1 X Slope (%)	2.7		X Walk 2 X Slope (%)	N/A

N/A	Ramp inside XWalk1?	N/A	N/A	Ramp inside XWalk2?	N/A
	Road Slope (%)	2.7	N/A	Clear Space?	N/A
	Road X Slope (%)	6.0	N/A	Clear Space to XWalk (in)	N/A
N/A	Any Obstructions?	N/A	N/A	Storm Grate/Utility Hazard?	N/A
	Obstruction Type			Storm Grate/Utility Type	
		N/A			N/A
			Yes	Surface Condition? (G/P)	Good

**Remove & Replace Entire Ramp.**
