Access Compliance Report Public Rights-of-Way (Curb Ramps)

Intersection ID: 8329 Main Street: BEATTIES FORD RD **Cross Street: LASALLE ST** Location: NE ADA ID: 616A5E85967C

Ramp Type: Perp Initial Pass/Fail: Fail **Overall Compliance: No** Severity Score: 21.25

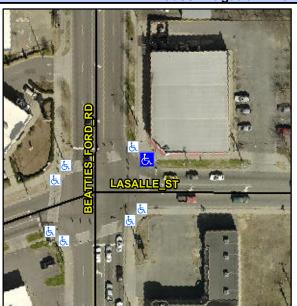
<u>,,</u>	i ossible ociution			I ICIG IVIC
1	Possible Solutions:	Complia	ance	Description
The same	Remove & Replace Entire Ramp.	N/A	Ramp	Length (in)
4	·	No	Ramp	Width (in)
S. Shell		N/A	Flare	Type LT
100		N/A	Flare	Slope LT (%)
8		N/A	Flare	Traversable LT
		N/A	Landir	ng Length (in)
	Surveyor Notes:	N/A	Landir	ng Width (in)
1	N/A	N/A	Landir	ng Slope (%)
4		N/A	Landir	ng X Slope (%)
		N/A	Landir	ng Curb? (Y/N)
2		N/A	Share	d Landing?
	PROW/ADA:	N/A	Gutte	Ponding?
1	Not Found, R304.5.1, R304.2.2	N/A	Gutte	Lip Ht (in)
The state of		N/A	Painte	ed X Walk1?
1			X Wal	k 1 Direction
		N/A	X Wal	k 1 Width (in)
			X Wal	k 1 Slope (%)
			X Wal	k 1 X Slope (%
		N/A	Ramp	inside XWalk1
			Road	Slope (%)

N/A
Surveyor Notes:			N/A
N/A			N/A
			N/A
			N/A
			N/A
PROW/ADA:			N/A
Not Found, R304.5.1, R3	04.2.2	<u>></u>	N/A
			N/A
Total Cost:	\$	1850.00
