# Access Compliance Report

## Public Rights-of-Way

### (Curb Ramps)

Intersection ID: 3385	Main Street: BRANDY RIDGE LN	Cross Street: POPLAR GROVE DR	Location:	S
ADA ID: 616B963EAAC7	Ramp Type: Perp	Initial Pass/Fail: Fail	Overall Compliance: No	Severity Score: 10
Codes/Mitigation Info/Possible Solution		Field Measurements/Component Compliance

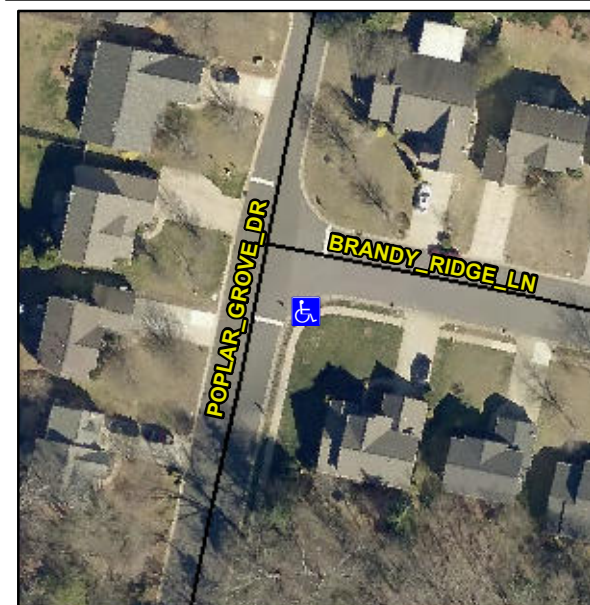
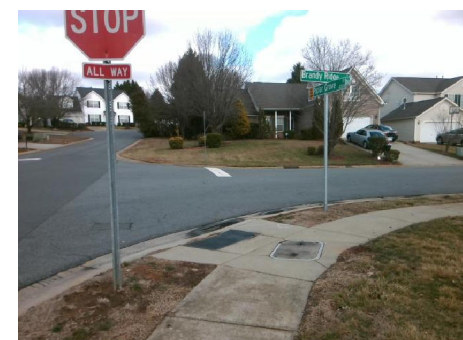
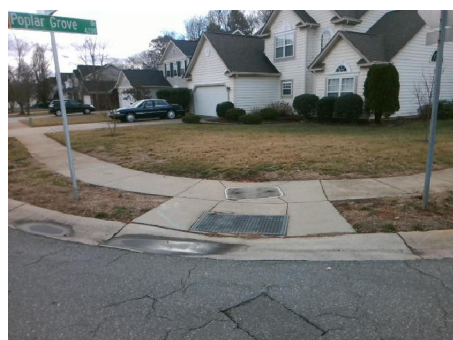
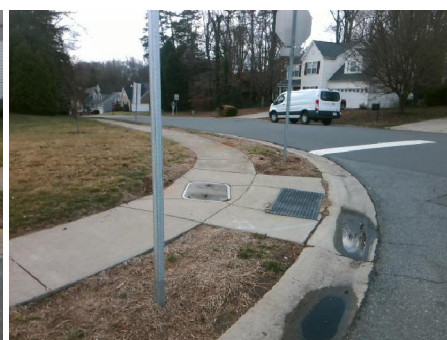
**Not Found, R304.5.1, R304.5.3**

Compliance	Description	Data	Compliance	Description	Data
N/A	Ramp Length (in)	48.0	Yes	Ramp Slope (%)	5.0
No	Ramp Width (in)	42.0	No	Ramp XSlope (%)	2.1
N/A	Flare Type LT	N/A	N/A	Flare Type RT	N/A
N/A	Flare Slope LT (%)	N/A	N/A	Flare Slope RT (%)	N/A
N/A	Flare Traversable LT?	N/A	N/A	Flare Traversable RT?	N/A
N/A	Landing Length (in)	N/A	N/A	DWS Provided?	N/A
N/A	Landing Width (in)	N/A	N/A	DWS Contrast?	N/A
N/A	Landing Slope (%)	N/A	N/A	DWS Length (in)	N/A
N/A	Landing X Slope (%)	N/A	N/A	DWS Full Width?	N/A
N/A	Landing Curb? (Y/N)	N/A	N/A	DWS Offset (in)	N/A
N/A	Shared Landing?	N/A			
N/A	Gutter Ponding?	N/A	N/A	Gutter Slope (%)	N/A
N/A	Gutter Lip Ht (in)	N/A	N/A	Gutter X Slope (%)	N/A
N/A	Painted X Walk1?	No	N/A	Painted X Walk2?	N/A
	X Walk 1 Direction	To NE		X Walk 2 Direction	N/A
N/A	X Walk 1 Width (in)	N/A	N/A	X Walk 2 Width (in)	N/A
	X Walk 1 Slope (%)	3.8		X Walk 2 Slope (%)	N/A
	X Walk 1 X Slope (%)	3.4		X Walk 2 X Slope (%)	N/A

N/A	Ramp inside XWalk1?	N/A	N/A	Ramp inside XWalk2?	N/A
	Road Slope (%)	N/A	N/A	Clear Space?	N/A
	Road X Slope (%)	N/A	N/A	Clear Space to XWalk (in)	N/A
N/A	Any Obstructions?	N/A	N/A	Storm Grate/Utility Hazard?	N/A
	Obstruction Type			Storm Grate/Utility Type	
		N/A			N/A
			Yes	Surface Condition? (G/P)	Good

**Remove & Replace Entire Ramp.**
