# Access Compliance Report

## Public Rights-of-Way

### (Curb Ramps)

Intersection ID: 45240	Main Street: BEGONIA_DR	Cross Street: BLAZE_MANOR_LN	Location: SE
ADA ID: 6171B6075548	Ramp Type: PerpDiag	Initial Pass/Fail: Fail	Overall Compliance: No
Severity Score: 22.5			
Codes/Mitigation Info/Possible Solution		Field Measurements/Component Compliance

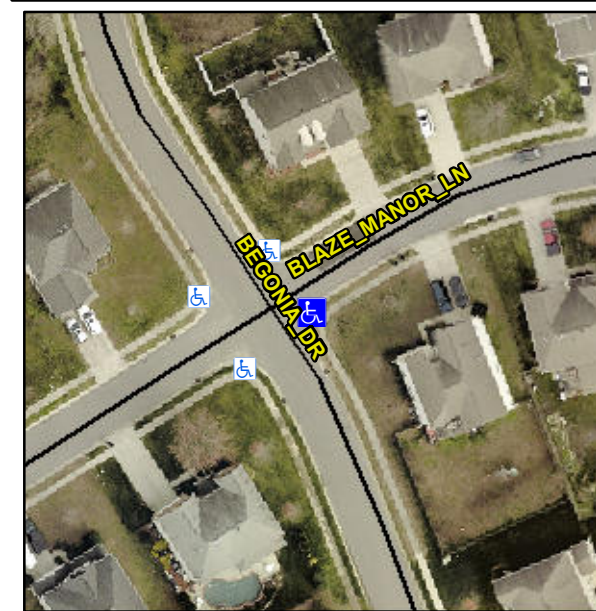
**Not Found, R304.5.1, R304.2.2, R304.5.3**

Compliance	Description	Data	Compliance	Description	Data
N/A	Ramp Length (in)	48.0	No	Ramp Slope (%)	9.7
No	Ramp Width (in)	47.5	No	Ramp XSlope (%)	4.0
N/A	Flare Type LT	N/A	N/A	Flare Type RT	N/A
N/A	Flare Slope LT (%)	N/A	N/A	Flare Slope RT (%)	N/A
N/A	Flare Traversable LT?	N/A	N/A	Flare Traversable RT?	N/A
N/A	Landing Length (in)	N/A	N/A	DWS Provided?	N/A
N/A	Landing Width (in)	N/A	N/A	DWS Contrast?	N/A
N/A	Landing Slope (%)	N/A	N/A	DWS Length (in)	N/A
N/A	Landing X Slope (%)	N/A	N/A	DWS Full Width?	N/A
N/A	Landing Curb? (Y/N)	N/A	N/A	DWS Offset (in)	N/A
N/A	Shared Landing?	N/A			
N/A	Gutter Ponding?	N/A	N/A	Gutter Slope (%)	N/A
N/A	Gutter Lip Ht (in)	N/A	N/A	Gutter X Slope (%)	N/A
N/A	Painted X Walk1?	No	N/A	Painted X Walk2?	No
	X Walk 1 Direction	To NW		X Walk 2 Direction	To SW
N/A	X Walk 1 Width (in)	N/A	N/A	X Walk 2 Width (in)	N/A
	X Walk 1 Slope (%)	2.1		X Walk 2 Slope (%)	2.2
	X Walk 1 X Slope (%)	3.0		X Walk 2 X Slope (%)	1.8

N/A	Ramp inside XWalk1?	N/A	N/A	Ramp inside XWalk2?	N/A
	Road Slope (%)	2.0	N/A	Clear Space?	N/A
	Road X Slope (%)	2.8	N/A	Clear Space to XWalk (in)	N/A
N/A	Any Obstructions?	N/A	N/A	Storm Grate/Utility Hazard?	N/A
	Obstruction Type			Storm Grate/Utility Type	
		N/A			N/A
			Yes	Surface Condition? (G/P)	Good

**Remove & Replace Curb Ramp With Two New Directional Ramps or Equivalent.**
