Access Compliance Report Public Rights-of-Way (Curb Ramps)

0 1						
Intersection ID: 3131	Main Str	Main Street: SANDMAN_LN			Cross Street: N/A				Location:	N	
ADA ID: 617F9B385B16	Ramp Type: Perp			Initial	Initial Pass/Fail: Fail Overall Compliance: N				Severity Score:	28.75	
Codes/Mitigation Info/Possible Solution					Field Measurements/Component Compliance						
	101/0	Possible Solutions:			Compliance Description			ata Compliance Description Data			
		Remove & Replace Entire	Ram).	N/A	Ramp Length (in)	55.0	No	Ramp Slope (%)	10.4	
A Carton	CAL Days		•		Yes	Ramp Width (in)	49.0	No	Ramp XSlope (%)	2.1	
	1133				N/A	Flare Type LT	N/A	N/A	Flare Type RT	N/A

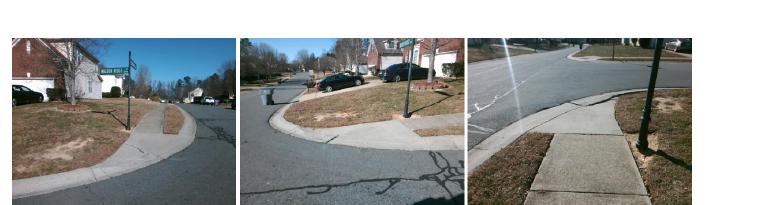
111.				N/A	Flare Slope LT (%)	N/A	N/A	Flare Slope RT (%)	N/A	
S. Mary 1	11895				N/A	Flare Traversable LT?	N/A	N/A	Flare Traversable RT?	N/A	
- BRANDE - S	1.40				N/A	Landing Length (in)	N/A	N/A	DWS Provided?	N/A	
ALL ROAD	A	Surveyor Notes:			N/A	Landing Width (in)	N/A	N/A	DWS Contrast?	N/A	
B B B	S. Martin	N/A			N/A	Landing Slope (%)	N/A	N/A	DWS Length (in)	N/A	
	AL AL				N/A	Landing X Slope (%)	N/A	N/A	DWS Full Width?	N/A	
the second second	m 194				N/A	Landing Curb? (Y/N)	N/A	N/A	DWS Offset (in)	N/A

100.30				N/A	Shared Landing?	N/A				
Jacob // Ana	Y 10 M	PROW/ADA:			N/A	Gutter Ponding?	N/A	N/A	Gutter Slope (%)	N/A	
	6. 98 Bat-	R304.2.2, R304.5.3, R302.7	,		N/A	Gutter Lip Ht (in)	N/A	N/A	Gutter X Slope (%)	N/A	
Martin 1		,,			N/A	Painted X Walk1?	No	N/A	Painted X Walk2?	N/A	
	A BANK					X Walk 1 Direction	To SW		X Walk 2 Direction	N/A	
				N/A	X Walk 1 Width (in)	N/A	N/A	X Walk 2 Width (in)	N/A		
Street 1 Name W	ALDEN RIDGE DR					X Walk 1 Slope (%)	0.3		X Walk 2 Slope (%)	N/A	
Stop Condition-Street 2	StopSign					X Walk 1 X Slope (%)	7.5		X Walk 2 X Slope (%)	N/A	
Street 2 Name	N/A				N/A	Ramp inside XWalk1?	N/A	N/A	Ramp inside XWalk2?	N/A	
Stop Condition-Street 1	N/A					Road Slope (%)	N/A	N/A	Clear Space?	N/A	
						Road X Slope (%)	N/A	N/A	Clear Space to XWalk (in)	N/A	
					N/A	Any Obstructions?	N/A	N/A	Storm Grate/Utility Hazard?	N/A	
		Total Cost:	\$	1850.00		Obstruction Type			Storm Grate/Utility Type

No Surface Condition? (G/P)

Poor
