Access Compliance Report

Public Rights-of-Way (Curb Ramps)

Intersection ID: 3757	Main Street: DAVIS_LAKE_PY	Cross Street: POPLAR_GROVE_DR	Location: SE
ADA ID: 618A17DFA1DA	Ramp Type: Perp	Initial Pass/Fail: Fail	Overall Compliance: No
Severity Score: 12.5			
Codes/Mitigation Info/Possible Solution		Field Measurements/Component Compliance

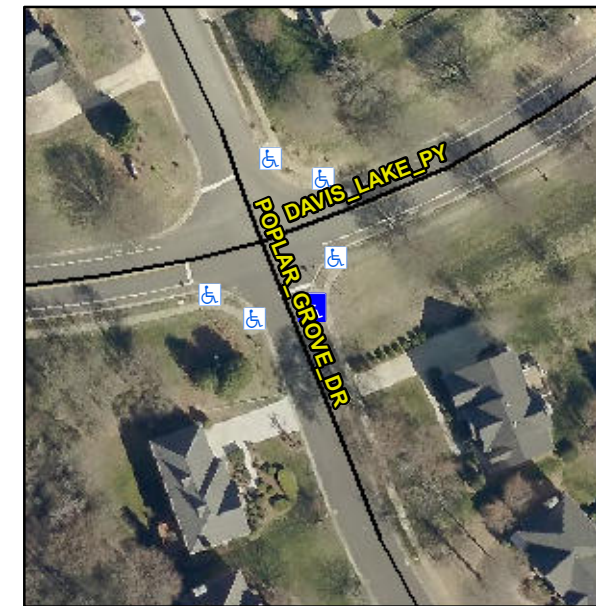
Not Found, R304.2.2

Compliance	Description	Data	Compliance	Description	Data
N/A	Ramp Length (in)	46.0	No	Ramp Slope (%)	9.5
Yes	Ramp Width (in)	48.0	Yes	Ramp XSlope (%)	1.9
N/A	Flare Type LT	N/A	N/A	Flare Type RT	N/A
N/A	Flare Slope LT (%)	N/A	N/A	Flare Slope RT (%)	N/A
N/A	Flare Traversable LT?	N/A	N/A	Flare Traversable RT?	N/A
N/A	Landing Length (in)	N/A	N/A	DWS Provided?	N/A
N/A	Landing Width (in)	N/A	N/A	DWS Contrast?	N/A
N/A	Landing Slope (%)	N/A	N/A	DWS Length (in)	N/A
N/A	Landing X Slope (%)	N/A	N/A	DWS Full Width?	N/A
N/A	Landing Curb? (Y/N)	N/A	N/A	DWS Offset (in)	N/A
N/A	Shared Landing?	N/A			
N/A	Gutter Ponding?	N/A	N/A	Gutter Slope (%)	N/A
N/A	Gutter Lip Ht (in)	N/A	N/A	Gutter X Slope (%)	N/A
N/A	Painted X Walk1?	No	N/A	Painted X Walk2?	N/A
	X Walk 1 Direction	To W		X Walk 2 Direction	N/A
N/A	X Walk 1 Width (in)	N/A	N/A	X Walk 2 Width (in)	N/A
	X Walk 1 Slope (%)	2.8		X Walk 2 Slope (%)	N/A
	X Walk 1 X Slope (%)	3.2		X Walk 2 X Slope (%)	N/A

N/A	Ramp inside XWalk1?	N/A	N/A	Ramp inside XWalk2?	N/A
	Road Slope (%)	N/A	N/A	Clear Space?	N/A
	Road X Slope (%)	N/A	N/A	Clear Space to XWalk (in)	N/A
N/A	Any Obstructions?	N/A	N/A	Storm Grate/Utility Hazard?	N/A
	Obstruction Type			Storm Grate/Utility Type	
		N/A			N/A
			Yes	Surface Condition? (G/P)	Good

Remove & Replace Entire Ramp.
