Access Compliance Report

Public Rights-of-Way

(Curb Ramps)

| Intersection ID: 8938 | Main Street: NORRIS_AV | Cross Street: NEWLAND_RD | Location: SW |

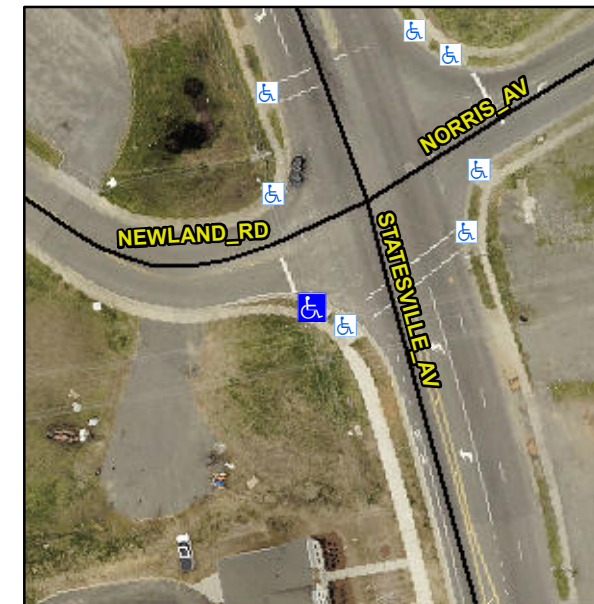
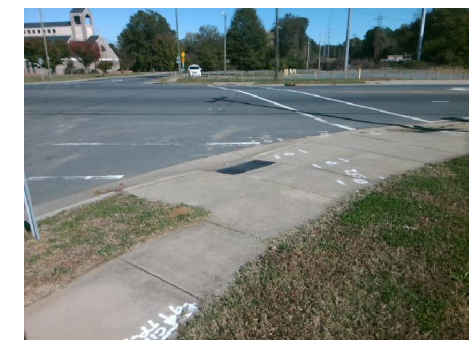
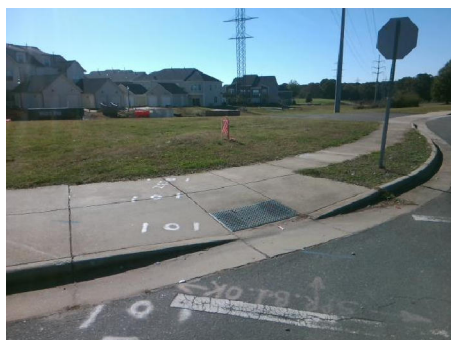
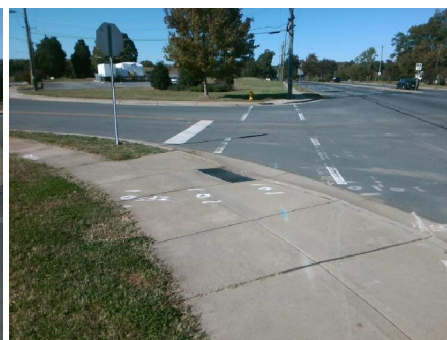
Not Found, R304.5.1, R304.2.2

| Compliance | Description | Data | Compliance | Description | Data |
|---|---|---|---|---|---|
| N/A | Ramp Length (in) | 60.0 | No | Ramp Slope (%) | 10.0 |
| No | Ramp Width (in) | 43.0 | Yes | Ramp XSlope (%) | 0.4 |

Remove & Replace Entire Ramp.
