Access Compliance Report

Public Rights-of-Way

(Curb Ramps)

Intersection ID: 11745	Main Street: E_19TH_ST	Cross Street: HARRILL_ST	Location:	N
ADA ID: 619DE73ADD6C	Ramp Type: BlendTrans2	Initial Pass/Fail: Fail	Overall Compliance: No	Severity Score: 17.5
Codes/Mitigation Info/Possible Solution		Field Measurements/Component Compliance

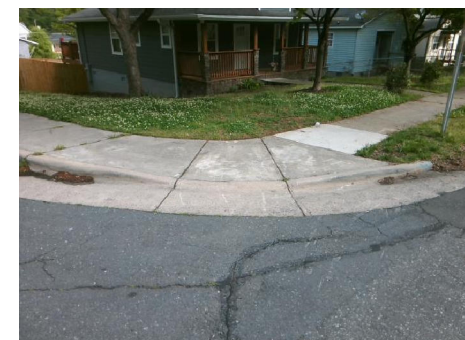
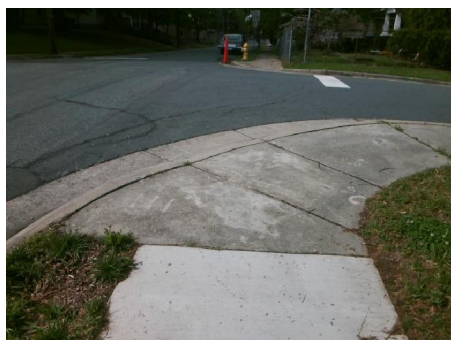
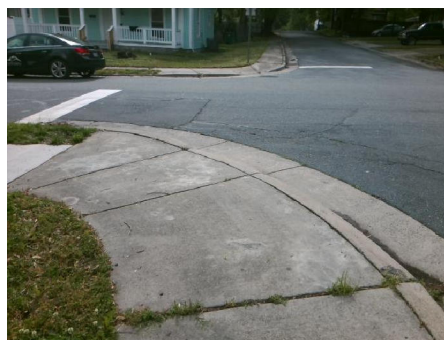
Compliance	Description	Data	Compliance	Description	Data
N/A	Ramp Length (in)	67.0	Yes	BlendTrans Slope (%)	1.1
No	Ramp Width (in)	34.0	Yes	BlendTrans XSlope (%)	1.5
N/A	Flare Type LT	N/A	N/A	Flare Type RT	N/A
N/A	Flare Slope LT (%)	N/A	N/A	Flare Slope RT (%)	N/A
N/A	Flare Traversable LT?	N/A	N/A	Flare Traversable RT?	N/A
N/A	Landing Length (in)	N/A	N/A	DWS Provided?	N/A
N/A	Landing Width (in)	N/A	N/A	DWS Contrast?	N/A
N/A	Landing Slope (%)	N/A	N/A	DWS Length (in)	N/A
N/A	Landing X Slope (%)	N/A	N/A	DWS Full Width?	N/A
N/A	Landing Curb? (Y/N)	N/A	N/A	DWS Offset (in)	N/A
N/A	Shared Landing?	N/A			
N/A	Gutter Ponding?	N/A	N/A	Gutter Slope (%)	N/A
N/A	Gutter Lip Ht (in)	N/A	N/A	Gutter X Slope (%)	N/A
N/A	Painted X Walk1?	No	N/A	Painted X Walk2?	No
	X Walk 1 Direction	To SW		X Walk 2 Direction	To SE
	X Walk 1 Width (in)	N/A		X Walk 2 Width (in)	N/A
	X Walk 1 Slope (%)	3.5		X Walk 2 Slope (%)	2.1
	X Walk 1 X Slope (%)	1.2		X Walk 2 X Slope (%)	4.3

N/A	Ramp inside XWalk1?	N/A	N/A	Ramp inside XWalk2?	N/A
	Road Slope (%)	2.4		Clear Space?	N/A
	Road X Slope (%)	5.1	N/A	Clear Space to XWalk (in)	N/A
N/A	Any Obstructions?	N/A	N/A	Storm Grate/Utility Hazard?	N/A
	Obstruction Type			Storm Grate/Utility Type	
		N/A			N/A
			Yes	Surface Condition? (G/P)	Good
			No	Curb Slope (%)	12.1

Remove & Replace Curb Ramp With Two New Directional Ramps or Equivalent.
