Access Compliance Report

Public Rights-of-Way

(Curb Ramps)

Intersection ID: 19611	Main Street: FOXCROFT_RD	Cross Street: Warburton_RD	Location: SE
ADA ID: 61A97C3B8F9D	Ramp Type: PerpDiag	Initial Pass/Fail: Fail	Overall Compliance: No
Severity Score: 13.75			
Codes/Mitigation Info/Possible Solution		Field Measurements/Component Compliance

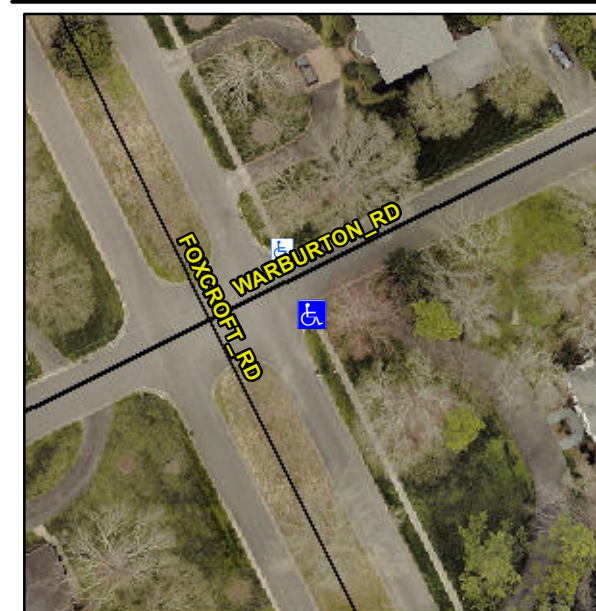
Not Found, R304.2.2, R304.5.3

Compliance	Description	Data	Compliance	Description	Data
N/A	Ramp Length (in)	58.0	No	Ramp Slope (%)	10.8
Yes	Ramp Width (in)	48.0	No	Ramp XSlope (%)	2.9
N/A	Flare Type LT	N/A	N/A	Flare Type RT	N/A
N/A	Flare Slope LT (%)	N/A	N/A	Flare Slope RT (%)	N/A
N/A	Flare Traversable LT?	N/A	N/A	Flare Traversable RT?	N/A
N/A	Landing Length (in)	N/A	N/A	DWS Provided?	N/A
N/A	Landing Width (in)	N/A	N/A	DWS Contrast?	N/A
N/A	Landing Slope (%)	N/A	N/A	DWS Length (in)	N/A
N/A	Landing X Slope (%)	N/A	N/A	DWS Full Width?	N/A
N/A	Landing Curb? (Y/N)	N/A	N/A	DWS Offset (in)	N/A
N/A	Shared Landing?	N/A			
N/A	Gutter Ponding?	N/A	N/A	Gutter Slope (%)	N/A
N/A	Gutter Lip Ht (in)	N/A	N/A	Gutter X Slope (%)	N/A
N/A	Painted X Walk1?	No	N/A	Painted X Walk2?	No
	X Walk 1 Direction	To N		X Walk 2 Direction	To SW
N/A	X Walk 1 Width (in)	N/A	N/A	X Walk 2 Width (in)	N/A
	X Walk 1 Slope (%)	0.9		X Walk 2 Slope (%)	1.9
	X Walk 1 X Slope (%)	1.8		X Walk 2 X Slope (%)	2.3

N/A	Ramp inside XWalk1?	N/A	N/A	Ramp inside XWalk2?	N/A
	Road Slope (%)	0.6	N/A	Clear Space?	N/A
	Road X Slope (%)	3.3	N/A	Clear Space to XWalk (in)	N/A
N/A	Any Obstructions?	N/A	N/A	Storm Grate/Utility Hazard?	N/A
	Obstruction Type			Storm Grate/Utility Type	
		N/A			N/A
		Yes		Surface Condition? (G/P)	Good

Remove & Replace Curb Ramp With Two New Directional Ramps or Equivalent.
