# Access Compliance Report

## Public Rights-of-Way

### (Curb Ramps)

Intersection ID: 29136	Main Street: DEATON_HILL_DR	Cross Street: FOREST_GROVE_CT	Location: N
ADA ID: 61BEF3A55010	Ramp Type: PerpDiag	Initial Pass/Fail: Fail	Overall Compliance: No
Severity Score: 46.25			
Codes/Mitigation Info/Possible Solution		Field Measurements/Component Compliance

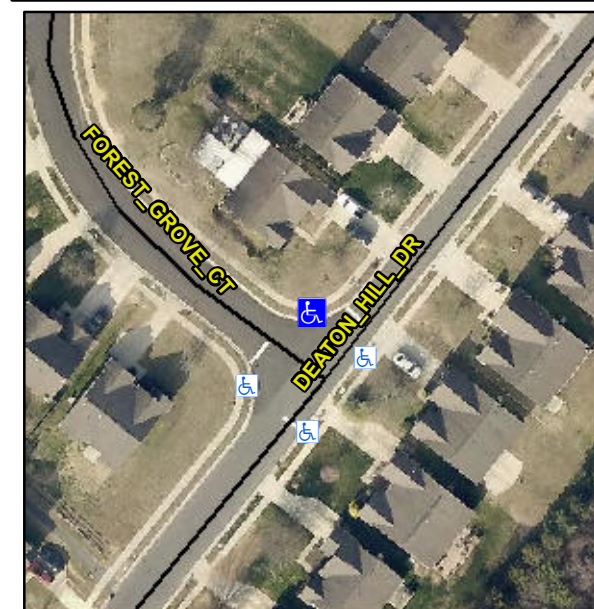
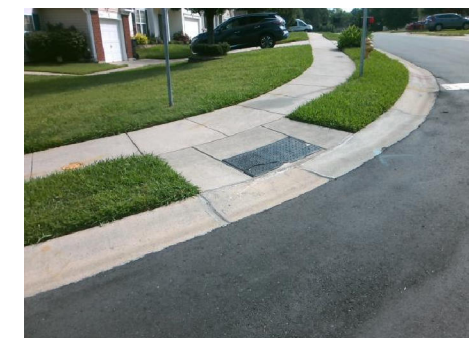
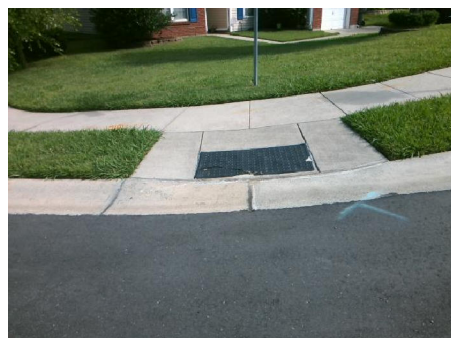
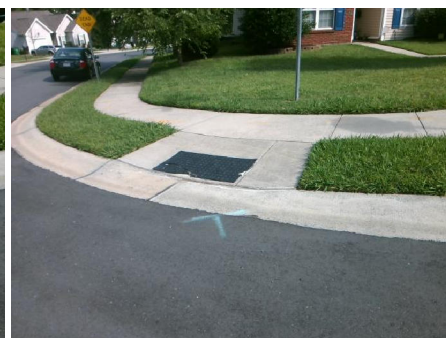
Compliance	Description	Data	Compliance	Description	Data
N/A	Ramp Length (in)	48.5	No	Ramp Slope (%)	9.4
No	Ramp Width (in)	47.0	No	Ramp XSlope (%)	7.1
N/A	Flare Type LT	N/A	N/A	Flare Type RT	N/A
N/A	Flare Slope LT (%)	N/A	N/A	Flare Slope RT (%)	N/A
N/A	Flare Traversable LT?	N/A	N/A	Flare Traversable RT?	N/A
N/A	Landing Length (in)	N/A	N/A	DWS Provided?	N/A
N/A	Landing Width (in)	N/A	N/A	DWS Contrast?	N/A
N/A	Landing Slope (%)	N/A	N/A	DWS Length (in)	N/A
N/A	Landing X Slope (%)	N/A	N/A	DWS Full Width?	N/A
N/A	Landing Curb? (Y/N)	N/A	N/A	DWS Offset (in)	N/A
N/A	Shared Landing?	N/A			
N/A	Gutter Ponding?	N/A	N/A	Gutter Slope (%)	N/A
N/A	Gutter Lip Ht (in)	N/A	N/A	Gutter X Slope (%)	N/A
N/A	Painted X Walk1?	No	N/A	Painted X Walk2?	No
	X Walk 1 Direction	To SE		X Walk 2 Direction	To SW
N/A	X Walk 1 Width (in)	N/A	N/A	X Walk 2 Width (in)	N/A
	X Walk 1 Slope (%)	3.9		X Walk 2 Slope (%)	4.9
	X Walk 1 X Slope (%)	6.4		X Walk 2 X Slope (%)	3.6

N/A	Ramp inside XWalk1?	N/A	N/A	Ramp inside XWalk2?	N/A
	Road Slope (%)	6.8	N/A	Clear Space?	N/A
	Road X Slope (%)	1.7	N/A	Clear Space to XWalk (in)	N/A
N/A	Any Obstructions?	N/A	N/A	Storm Grate/Utility Hazard?	N/A
	Obstruction Type			Storm Grate/Utility Type	
		N/A			N/A
		Yes		Surface Condition? (G/P)	Good

**Remove & Replace Curb Ramp With Two New Directional Ramps or Equivalent.**

**R304.5.1, R304.2.2, R304.5.3**
