Access Compliance Report

Public Rights-of-Way

(Curb Ramps)

Intersection ID: 21456	Main Street: REGENT RIDGE LN	Cross Street: WITHERS MILL DR	Location: S
ADA ID: 61C23583F0B6	Ramp Type: BlendTrans2	Initial Pass/Fail: Fail	Overall Compliance: No
Severity Score: 21.25			
Codes/Mitigation Info/Possible Solution		Field Measurements/Component Compliance

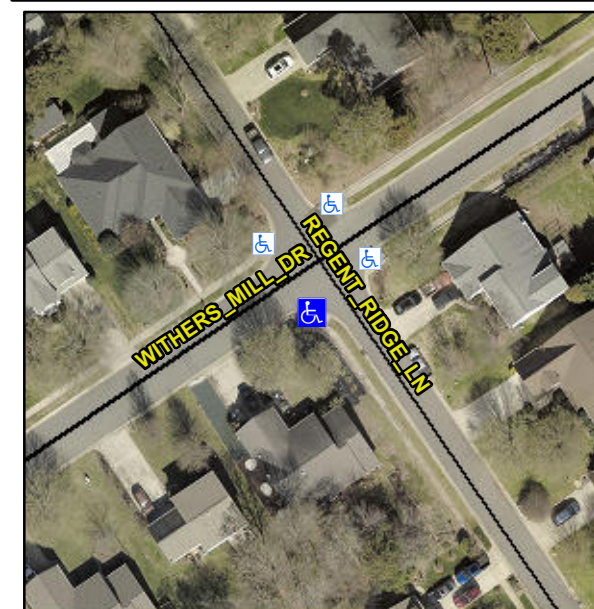
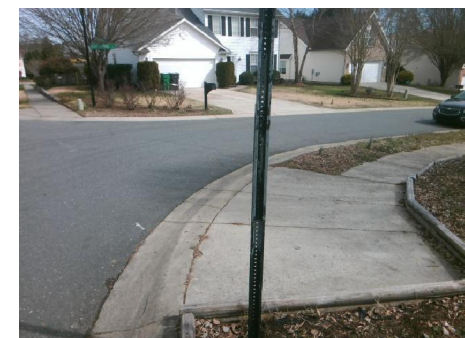
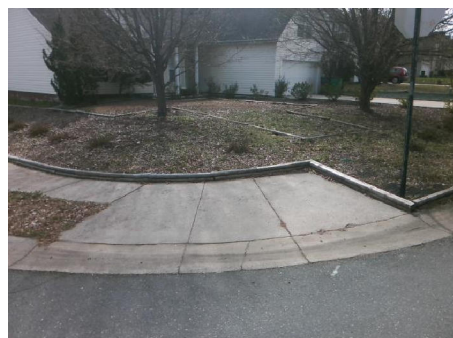
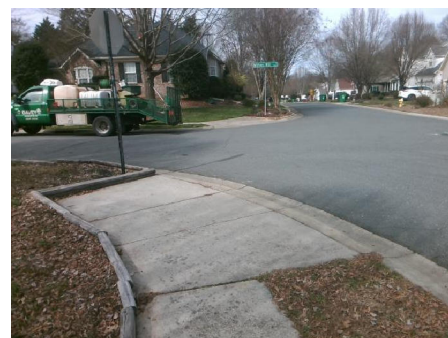
Compliance	Description	Data	Compliance	Description	Data
N/A	Ramp Length (in)	94.0	Yes	BlendTrans Slope (%)	2.7
No	Ramp Width (in)	36.0	No	BlendTrans XSlope (%)	6.1
N/A	Flare Type LT	N/A	N/A	Flare Type RT	N/A
N/A	Flare Slope LT (%)	N/A	N/A	Flare Slope RT (%)	N/A
N/A	Flare Traversable LT?	N/A	N/A	Flare Traversable RT?	N/A
N/A	Landing Length (in)	N/A	N/A	DWS Provided?	N/A
N/A	Landing Width (in)	N/A	N/A	DWS Contrast?	N/A
N/A	Landing Slope (%)	N/A	N/A	DWS Length (in)	N/A
N/A	Landing X Slope (%)	N/A	N/A	DWS Full Width?	N/A
N/A	Landing Curb? (Y/N)	N/A	N/A	DWS Offset (in)	N/A
N/A	Shared Landing?	N/A			
N/A	Gutter Ponding?	N/A	N/A	Gutter Slope (%)	N/A
N/A	Gutter Lip Ht (in)	N/A	N/A	Gutter X Slope (%)	N/A
N/A	Painted X Walk1?	No	N/A	Painted X Walk2?	No
	X Walk 1 Direction	To NE		X Walk 2 Direction	To NW
	X Walk 1 Width (in)	N/A		X Walk 2 Width (in)	N/A
	X Walk 1 Slope (%)	0.7		X Walk 2 Slope (%)	6.6
	X Walk 1 X Slope (%)	5.7		X Walk 2 X Slope (%)	0.3

N/A	Ramp inside XWalk1?	N/A	N/A	Ramp inside XWalk2?	N/A
	Road Slope (%)	4.0		Clear Space?	N/A
	Road X Slope (%)	4.2	N/A	Clear Space to XWalk (in)	N/A
N/A	Any Obstructions?	N/A	N/A	Storm Grate/Utility Hazard?	N/A
	Obstruction Type			Storm Grate/Utility Type	
		N/A			N/A
			Yes	Surface Condition? (G/P)	Good
			N/A	Curb Slope (%)	1.0

Possible Solutions:

Remove & Replace Curb Ramp With Two New Directional Ramps or Equivalent.

R304.5.1, R304.5.3
