# Access Compliance Report

## Public Rights-of-Way

### (Curb Ramps)

Intersection ID: N/A	Main Street: CALAWOOD_WY	Cross Street: BECKSTONE_WY	Location: SW
ADA ID: 61DBF810163C	Ramp Type: Directional1	Initial Pass/Fail: Fail	Overall Compliance: No
		Severity Score: 12.5

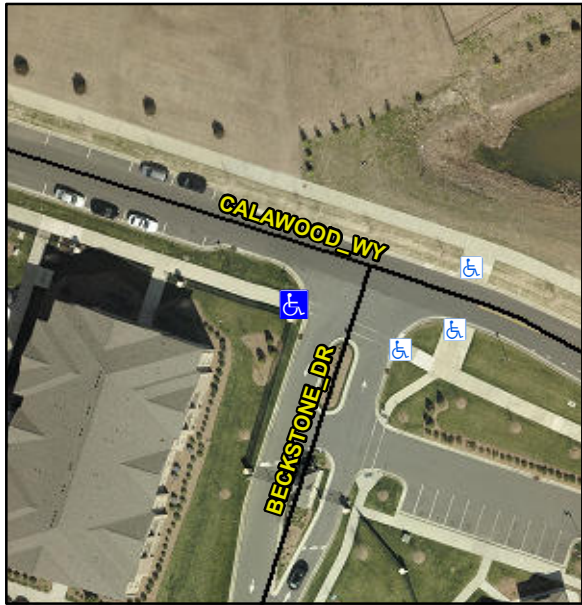
<div>Street 1 Name<div>BECKSTONE WY</div></div> <div>Stop Condition-Street 1<div>StopSign</div></div> <div>Street 2 Name<div>N/A</div></div> <div>Stop Condition-Street 2<div>N/A</div></div>	Possible Solutions:		Compliance	Description	Data	Compliance	Description	Data
	Remove & Replace Entire Ramp.		N/A	Ramp Length (in)	37.0	N/A	Grade Break?	N/A
			Yes	Ramp Width (in)	48.0	N/A	Grade Break Slope (%)	0.0
			No	Ramp Slope (%)	9.7	N/A	Grade Break XSlope (%)	0.0
			Yes	Ramp XSlope (%)	1.6			
			N/A	Flare Type LT	N/A	N/A	Flare Type RT	N/A
			N/A	Flare Slope LT (%)	N/A	N/A	Flare Slope RT (%)	0.0
			N/A	Flare Traversable LT?	N/A	N/A	Flare Traversable RT?	N/A
	Surveyor Notes:		N/A	Landing Length (in)	0.0	N/A	DWS Provided?	N/A
	N/A		N/A	Landing Width (in)	0.0	N/A	DWS Contrast?	N/A
			N/A	Landing Slope (%)	0.0	N/A	DWS Length (in)	N/A

N/A	Landing X Slope (%)	0.0	N/A	DWS Full Width?	N/A
	PROW/ADA:		N/A	Landing Curb? (Y/N)	N/A	N/A	DWS Offset LT (in)	N/A
	R304.2.2		N/A	Shared Landing?	N/A	N/A	DWS Offset RT (in)	N/A
			N/A	Gutter Ponding?	0.0	N/A	Gutter Slope (%)	N/A
			N/A	Gutter Lip Ht (in)	0.0	N/A	Gutter X Slope (%)	N/A
			N/A	Painted X Walk1?	Yes		Road Slope (%)	1.4
				X Walk 1 Direction	To E		Road X Slope (%)	1.1
				X Walk 1 Width (in)	59.0		Clear Space?	N/A
				X Walk 1 Slope (%)	1.4	N/A	Clear Space to XWalk (in)	N/A
				X Walk 1 X Slope (%)	1.1	N/A	Storm Grate/Utility Hazard?	N/A
			N/A	Ramp inside XWalk1?	Yes		Storm Grate/Utility Type	
			N/A	Any Obstructions?	N/A			N/A
				Obstruction Type		Yes	Surface Condition? (G/P)	Good
						N/A	Curb Slope (%)	7.9
Total Cost:		\$ 1600.00
