Access Compliance Report

Public Rights-of-Way

(Curb Ramps)

Intersection ID: 18326	Main Street: E_WOODLAWN_RD	Cross Street: PINEHURST_PL	Location: SE
ADA ID: 61E3DE7A90F2	Ramp Type: Perp	Initial Pass/Fail: Fail	Overall Compliance: No
		Severity Score: 35

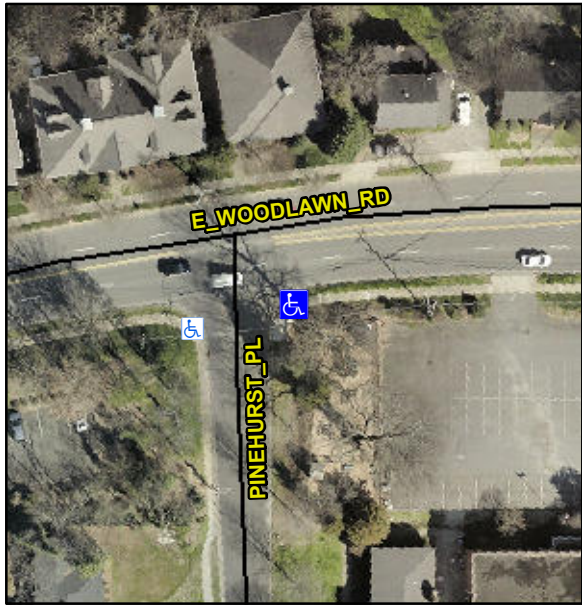
Possible Solutions:		Compliance	Description	Data	Compliance	Description	Data
	Remove & Replace Entire Ramp.		N/A	Ramp Length (in)	108.0	No	Ramp Slope (%)	12.1
			No	Ramp Width (in)	45.0	No	Ramp XSlope (%)	3.8
			N/A	Flare Type LT	N/A	N/A	Flare Type RT	N/A
			N/A	Flare Slope LT (%)	N/A	N/A	Flare Slope RT (%)	N/A
			N/A	Flare Traversable LT?	N/A	N/A	Flare Traversable RT?	N/A
			N/A	Landing Length (in)	N/A	N/A	DWS Provided?	N/A
			N/A	Landing Width (in)	N/A	N/A	DWS Contrast?	N/A
			N/A	Landing Slope (%)	N/A	N/A	DWS Length (in)	N/A
			N/A	Landing X Slope (%)	N/A	N/A	DWS Full Width?	N/A
Surveyor Notes:		N/A	N/A	Landing Curb? (Y/N)	N/A	N/A	DWS Offset (in)	N/A
PROW/ADA:		Not Found, R304.5.1, R304.2.2, R304.5.3	N/A	Shared Landing?	N/A	N/A	Gutter Slope (%)	N/A
			N/A	Gutter Ponding?	N/A	N/A	Gutter X Slope (%)	N/A
			N/A	Gutter Lip Ht (in)	N/A	N/A	Gutter X Slope (%)	N/A
