## Access Compliance Report Public Rights-of-Way (Curb Ramps)

Intersection ID: 30507	: 30507 Main Street: GOLDEN_SUN_CT			Street:	PLANTERS_ESTATES	Location:	SW		
ADA ID: 61F44A20823	7 Ramp Type: PerpDiag			Initial Pass/Fail: Fail Overall Compliance: No				o Severity Score:	36.25
Codes/Mitigation Info/Possible Solution				Field Measurements/Component Compliance					
	ALL STREET	Possible Solutions:		Compliance Description			Data Compliance Description		
		Remove & Replace Curb Ramp V Two New Directional Ramps or Equivalent.	Nith	N/A	Ramp Length (in)	81.0	Yes	Ramp Slope (%)	7.9
				No	Ramp Width (in)	28.5	No	Ramp XSlope (%)	2.4
				N/A	Flare Type LT	N/A	N/A	Flare Type RT	N/A
				N/A	Flare Slope LT (%)	N/A	N/A	Flare Slope RT (%)	N/A
				N/A	Flare Traversable LT?	N/A	N/A	Flare Traversable RT?	N/A
PLANTITED				N/A	Landing Length (in)	N/A	N/A	DWS Provided?	N/A
MALTER'S		Surveyor Notes:		N/A	Landing Width (in)	N/A	N/A	DWS Contrast?	N/A
AND AND A		N/A		N/A	Landing Slope (%)	N/A	N/A	DWS Length (in)	N/A

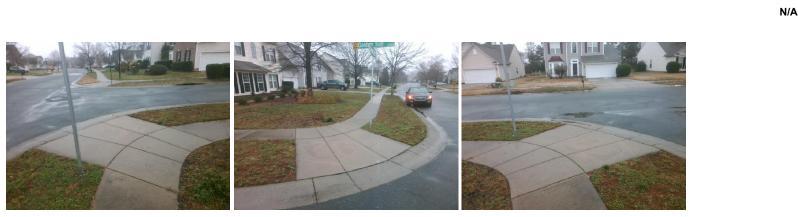
8. China	N304.3.1, N304.3.3		N/A	Painted X Walk1?	No	N/A	Painted X Walk2?	No
					X Walk 1 Direction	To SE		X Walk 2 Direction	To NE
				N/A	X Walk 1 Width (in)	N/A	N/A	X Walk 2 Width (in)	N/A
Street 1 Name	GOLDEN SUN CT	-			X Walk 1 Slope (%)	0.5		X Walk 2 Slope (%)	0.2
Stop Condition-Street 2	StopSign				X Walk 1 X Slope (%)	1.5		X Walk 2 X Slope (%)	1.8
Street 2 Name	PLANTERS ESTATES DR			N/A	Ramp inside XWalk1?	N/A	N/A	Ramp inside XWalk2?	N/A
Stop Condition-Street 1	None				Road Slope (%)	1.0	N/A	Clear Space?	N/A
					Road X Slope (%)	4.3	N/A	Clear Space to XWalk (in)	N/A
				N/A	Any Obstructions?	4.0 N/A	N/A	Storm Grate/Utility Hazard?	N/A
		Total Cost: \$	3200.00		Obstruction Type			Storm Grate/Utility Type	
		· · · ·				N/A			N/A

**Yes** Surface Condition? (G/P)

Good
