Access Compliance Report

Public Rights-of-Way

(Curb Ramps)

Intersection ID: 11779	Main Street: KEMPTON_PL	Cross Street: PRUITT_ST	Location: SE
ADA ID: 61FC7FE66ABD	Ramp Type: Perp	Initial Pass/Fail: Fail	Overall Compliance: No
Severity Score: 21.25			
Codes/Mitigation Info/Possible Solution		Field Measurements/Component Compliance

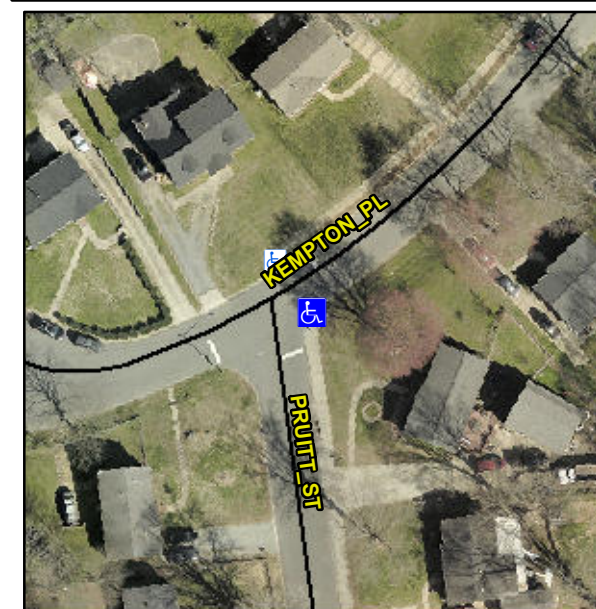
Not Found, R304.5.1, R304.5.3

Compliance	Description	Data	Compliance	Description	Data
N/A	Ramp Length (in)	66.5	Yes	Ramp Slope (%)	6.2
No	Ramp Width (in)	47.5	No	Ramp XSlope (%)	5.2
N/A	Flare Type LT	N/A	N/A	Flare Type RT	N/A
N/A	Flare Slope LT (%)	N/A	N/A	Flare Slope RT (%)	N/A
N/A	Flare Traversable LT?	N/A	N/A	Flare Traversable RT?	N/A
N/A	Landing Length (in)	N/A	N/A	DWS Provided?	N/A
N/A	Landing Width (in)	N/A	N/A	DWS Contrast?	N/A
N/A	Landing Slope (%)	N/A	N/A	DWS Length (in)	N/A
N/A	Landing X Slope (%)	N/A	N/A	DWS Full Width?	N/A
N/A	Landing Curb? (Y/N)	N/A	N/A	DWS Offset (in)	N/A
N/A	Shared Landing?	N/A			
N/A	Gutter Ponding?	N/A	N/A	Gutter Slope (%)	N/A
N/A	Gutter Lip Ht (in)	N/A	N/A	Gutter X Slope (%)	N/A
N/A	Painted X Walk1?	No	N/A	Painted X Walk2?	N/A
	X Walk 1 Direction	To N		X Walk 2 Direction	N/A
N/A	X Walk 1 Width (in)	N/A	N/A	X Walk 2 Width (in)	N/A
	X Walk 1 Slope (%)	0.6		X Walk 2 Slope (%)	N/A
	X Walk 1 X Slope (%)	3.2		X Walk 2 X Slope (%)	N/A

N/A	Ramp inside XWalk1?	N/A	N/A	Ramp inside XWalk2?	N/A
	Road Slope (%)	N/A	N/A	Clear Space?	N/A
	Road X Slope (%)	N/A	N/A	Clear Space to XWalk (in)	N/A
N/A	Any Obstructions?	N/A	N/A	Storm Grate/Utility Hazard?	N/A
	Obstruction Type			Storm Grate/Utility Type	
		N/A			N/A
			Yes	Surface Condition? (G/P)	Good

Possible Solutions:

Remove & Replace Entire Ramp.
