Access Compliance Report Public Rights-of-Way (Curb Ramps)

Intersection ID: 12995	Main Street: FARMVIEW_RD					Location:	S			
				Cross Street: SUDBURY_RD						
ADA ID: 62046488BFFE Ramp Type: Perp			Initial P	Initial Pass/Fail: Fail Overall Compliance: No				o Severity Score:	8.75	
Codes/Mitigation Info/Possible Solution				Field Measurements/Component Compliance

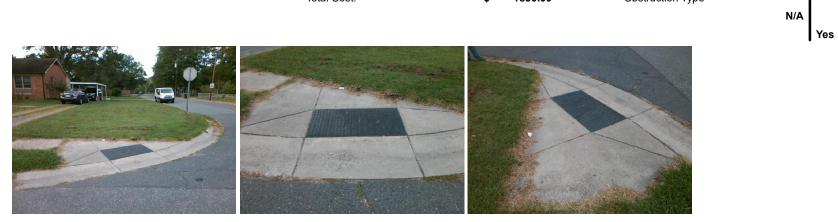
5. 5. 5. 5. 7.	*	Possible Solutions:		Compliance Description Data Co			Comp	Compliance Description Data		
	The second	Remove & Replace Entire Ramp		N/A	Ramp Length (in)	40.0	Yes	Ramp Slope (%)	6.5

C. J. S.			No	Ramp Width (in)	47.0	Yes	Ramp XSlope (%)	0.4	
See Veel	1 charles			N/A	Flare Type LT	N/A	N/A	Flare Type RT	N/A	
	O Main			N/A	Flare Slope LT (%)	N/A	N/A	Flare Slope RT (%)	N/A	
Some Some Some Some Some Some Some Some				N/A	Flare Traversable LT?	N/A	N/A	Flare Traversable RT?	N/A	
				N/A	Landing Length (in)	N/A	N/A	DWS Provided?	N/A	
the second se	1	Surveyor Notes:		N/A	Landing Width (in)	N/A	N/A	DWS Contrast?	N/A	
		N/A		N/A	Landing Slope (%)	N/A	N/A	DWS Length (in)	N/A	
	and the			N/A	Landing X Slope (%)	N/A	N/A	DWS Full Width?	N/A	
				N/A	Landing Curb? (Y/N)	N/A	N/A	DWS Offset (in)	N/A	
	11/16			N/A	Shared Landing?	N/A				
8		PROW/ADA:		N/A	Gutter Ponding?	N/A	N/A	Gutter Slope (%)	N/A	
Martin Carl	1	Not Found, R304.5.1		N/A	Gutter Lip Ht (in)	N/A	N/A	Gutter X Slope (%)	N/A	
	× 100			N/A	Painted X Walk1?	No	N/A	Painted X Walk2?	N/A	
	· · · · ·				X Walk 1 Direction	To NW		X Walk 2 Direction	N/A

N/A	X Walk 1 Width (in)	N/A	N/A	X Walk 2 Width (in)	N/A	
Street 1 Name	ARMVIEW RD				X Walk 1 Slope (%)	0.6		X Walk 2 Slope (%)	N/A	
Stop Condition-Street 2	StopSign				X Walk 1 X Slope (%)	3.7		X Walk 2 X Slope (%)	N/A	
Street 2 Name	N/A			N/A	Ramp inside XWalk1?	N/A	N/A	Ramp inside XWalk2?	N/A	
Stop Condition-Street 1	N/A				Road Slope (%)	N/A	N/A	Clear Space?	N/A	
					Road X Slope (%)	N/A	N/A	Clear Space to XWalk (in)	N/A	
				N/A	Any Obstructions?	N/A	N/A	Storm Grate/Utility Hazard?	N/A	
		Total Cost: \$	1850.00		Obstruction Type			Storm Grate/Utility Type		
						N/A			N/A
