Access Compliance Report Public Rights-of-Way (Curb Ramps)

Leastien	6		
Intersection ID: 10918	Main Street: MATHESON_AV		Cross Street: HOLT_ST			Location: S			
ADA ID: 621503F103F7	3F7 Ramp Type: PerpDiag		Initial F	Initial Pass/Fail: Fail Overall Compliance			ice: N	Severity Score:	26.25
Codes/Mitigation Info/Possible Solution				Field Measurements/Component Compliance					
		Possible Solutions:		Compliance Description			Data Compliance Description E		
		Remove & Replace Curb Ramp W Two New Directional Ramps or Equivalent.	Nith	N/A	Ramp Length (in)	61.0	No	Ramp Slope (%)	14.9
				Yes	Ramp Width (in)	65.0	No	Ramp XSlope (%)	4.2
				N/A	Flare Type LT	N/A	N/A	Flare Type RT	N/A
				N/A	Flare Slope LT (%)	N/A	N/A	Flare Slope RT (%)	N/A
				N/A	Flare Traversable LT?	N/A	N/A	Flare Traversable RT?	N/A
the Alexandree				N/A	Landing Length (in)	N/A	N/A	DWS Provided?	N/A
		Surveyor Notes:		N/A	Landing Width (in)	N/A	N/A	DWS Contrast?	N/A
B		N/A		N/A	Landing Slope (%)	N/A	N/A	DWS Length (in)	N/A

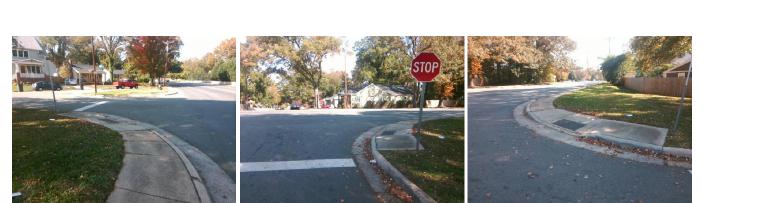
N/A	Landing X Slope (%)	N/A	N/A	DWS Full Width?	N/A
				N/A	Landing Curb? (Y/N)	N/A	N/A	DWS Offset (in)	N/A
and the second	1 200			N/A	Shared Landing?	N/A			
Fight Fight		PROW/ADA:		N/A	Gutter Ponding?	N/A	N/A	Gutter Slope (%)	N/A
	and the	Not Found, R304.2.2, R304.5.3		N/A	Gutter Lip Ht (in)	N/A	N/A	Gutter X Slope (%)	N/A
	,,		N/A	Painted X Walk1?	No	N/A	Painted X Walk2?	No	
	Cart and				X Walk 1 Direction	To NE		X Walk 2 Direction	To NW
				N/A	X Walk 1 Width (in)	N/A	N/A	X Walk 2 Width (in)	N/A
Street 1 Name	MATHESON AV				X Walk 1 Slope (%)	4.0		X Walk 2 Slope (%)	0.5
Stop Condition-Street 2	None				X Walk 1 X Slope (%)	2.1		X Walk 2 X Slope (%)	5.1
Street 2 Name	HOLT ST			N/A	Ramp inside XWalk1?	N/A	N/A	Ramp inside XWalk2?	N/A
Stop Condition-Street 1	StopSign				Road Slope (%)	4.6	N/A	Clear Space?	N/A
	_				Road X Slope (%)	5.2	N/A	Clear Space to XWalk (in)	N/A
				N/A	Any Obstructions?	N/A	N/A	Storm Grate/Utility Hazard?	N/A

Total Cost: \$ 3	3200.00		Obstruction Type			Storm Grate/Utility Type	
						N/A			N/A
